# INSPECTION REPORT

For the Property at:  
**31 MASSEY ST., #1**  
TORONTO, ON

Prepared for: ANDREW NICHOLSON  
Inspection Date: Monday, March 6, 2017  
Prepared by: Michael Tita

RE: Report No. 1014, v.2  
31 Massey St., #1  
Toronto, ON

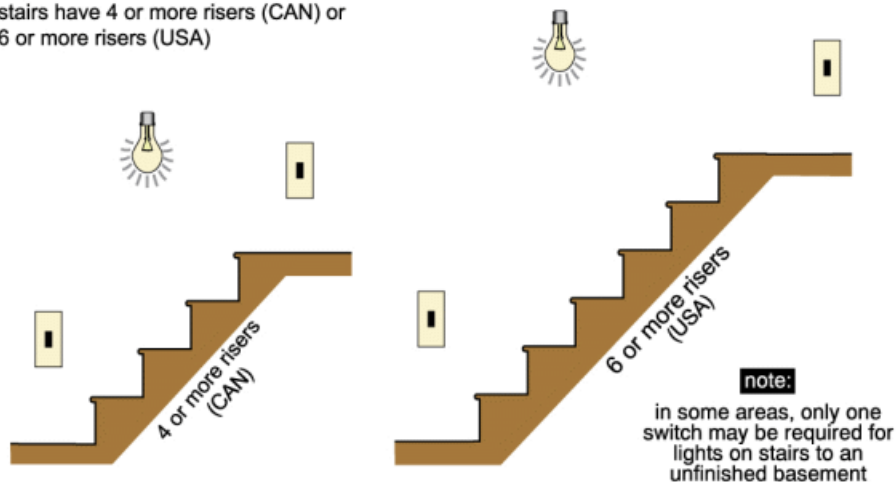
**1. Condition:** • 3-way not working as intended

**Implication(s):** Nuisance | Fall hazard

**Location:** First Floor Hall

stairway lighting requires switches at both the top and bottom of the stairs when the stairs have 4 or more risers (CAN) or 6 or more risers (USA)

**Task:** Repair

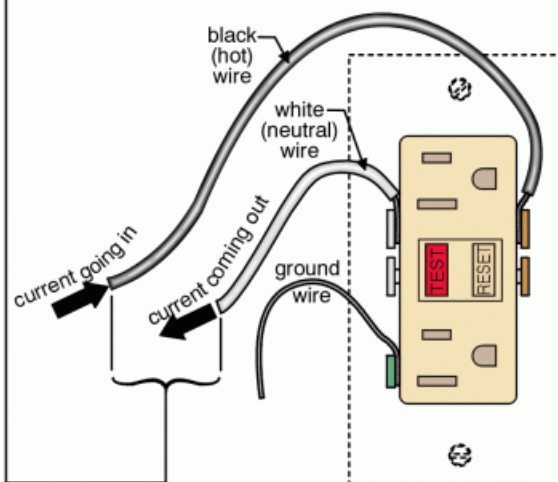
2. Condition: • [No GFCI \(Ground Fault Circuit Interrupter\)](#)

Implication(s): Electric shock

Location: Kitchen

Task: Install / Add New (as needed)

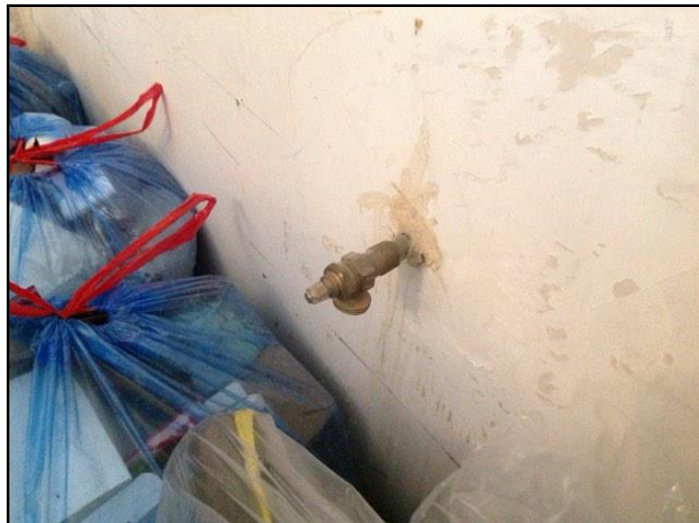
1.

**Exterior hose bibb:**

• Present

Add missing valve handle. \$5.

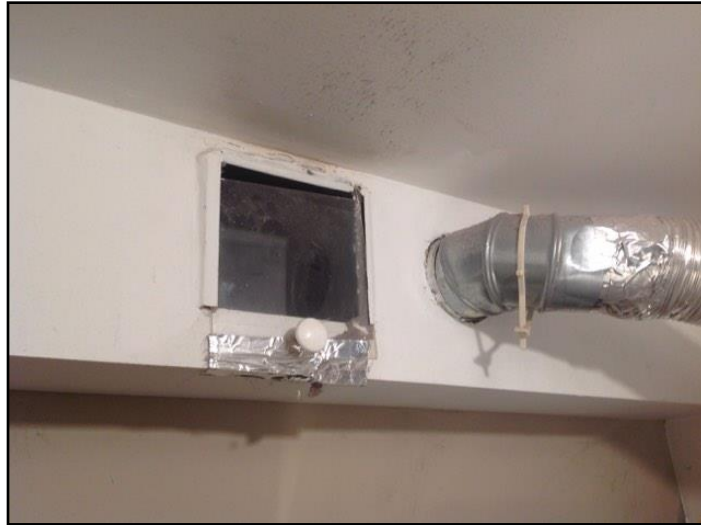
2.

**7.** • Repair additional lint trap above laundry machines. Ensure mesh is in place. Also should be cleaned out every 3to5 loads.

**Implication(s):** Exhaust pipe can fill up with lint if mesh is not in place

**Location:** Basement Laundry Area

**Task:** Repair

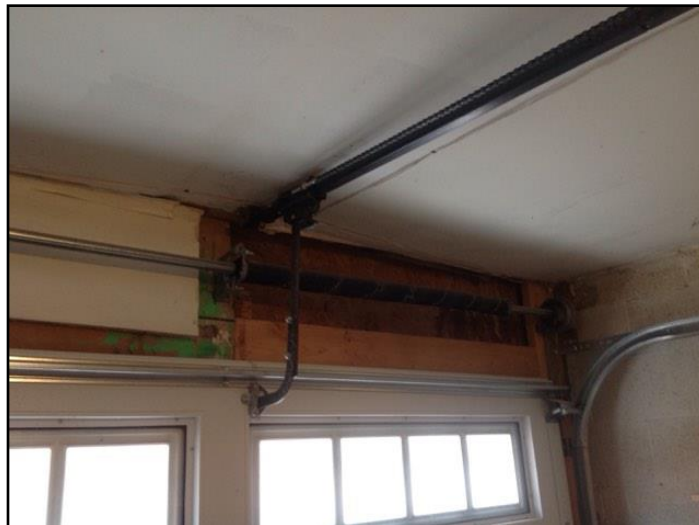
3.

**8. Condition:** • Wall damage

**Location:** Garage

Reseal drywall over garage door area

**Task:** Repair
