INSPECTION REPORT

For the Property at:
64 MARGUERETTA ST.
TORONTO, ON

Prepared for: ANDREW NICHOLSON
Inspection Date: Monday, May 1, 2017
Prepared by: Michael Tita

Elite Team Home Inspections
2325 Hurontario Street, Suite 322
Mississauga, ON L5A 4K4
416-453-4192
905-271-6381

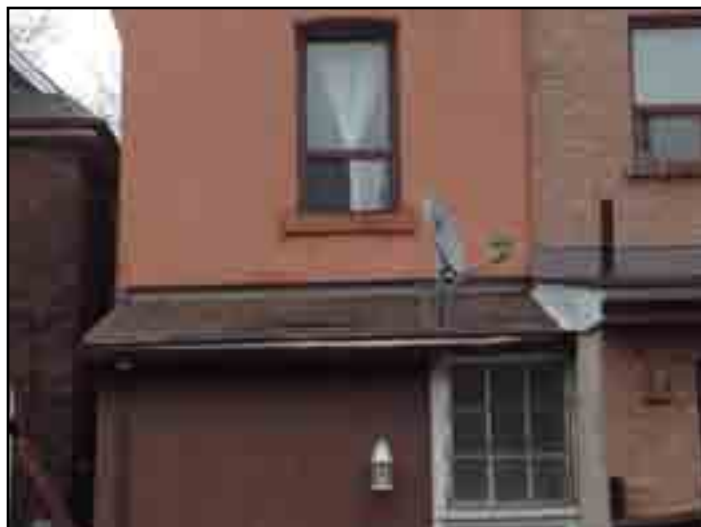
- 1. **Condition:** • [Near end of life expectancy](#)
Implication(s): Chance of water damage to contents, finishes and/or structure
Location: Rear Side
Task: Reshingling rear roof recommended
Time: before winter

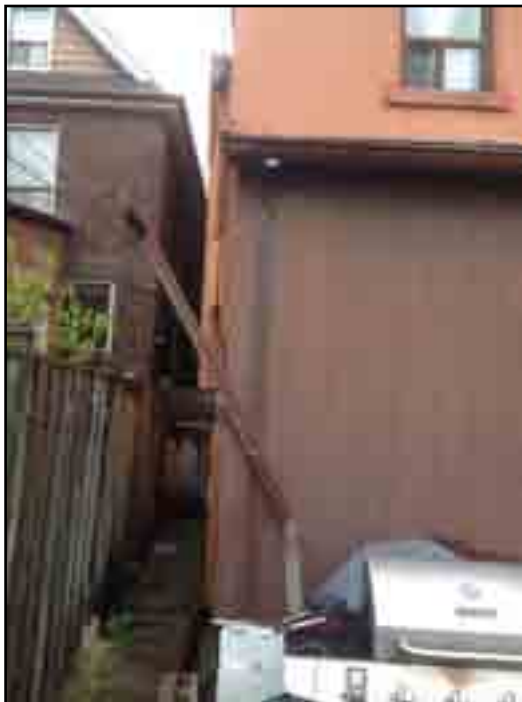
2.

- 5. Condition:** • [Loose connections](#)
- Implication(s):** Leakage
- Task:** Repair
- Time:** Immediate

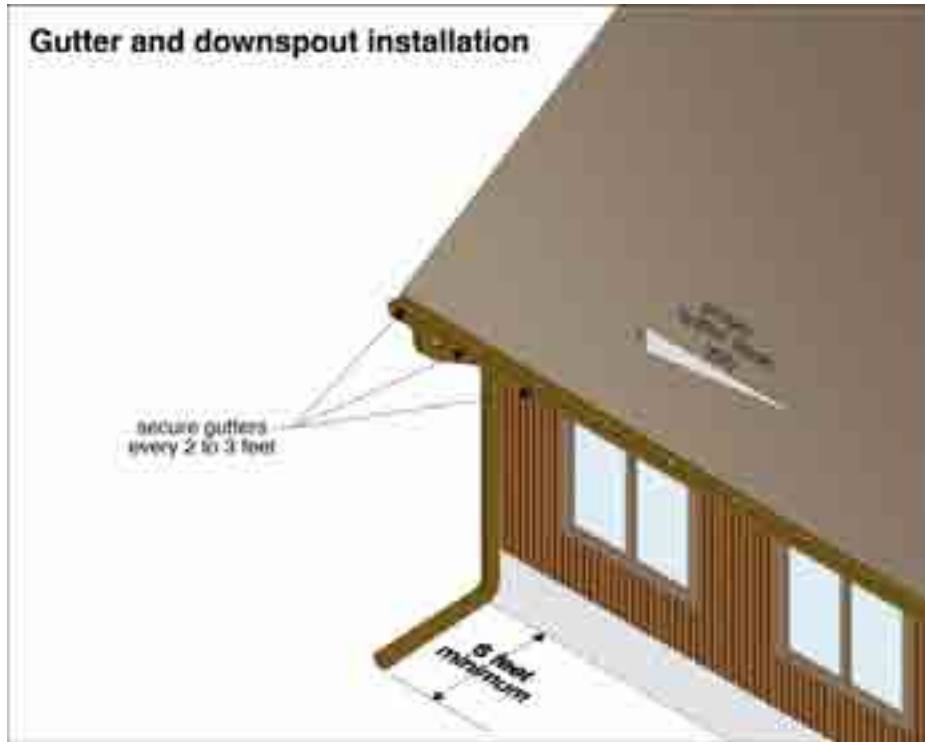
6. Condition: • [Downspouts end too close to building](#)

Implication(s): Chance of water damage to contents, finishes and/or structure

Task: Adjust / Correct

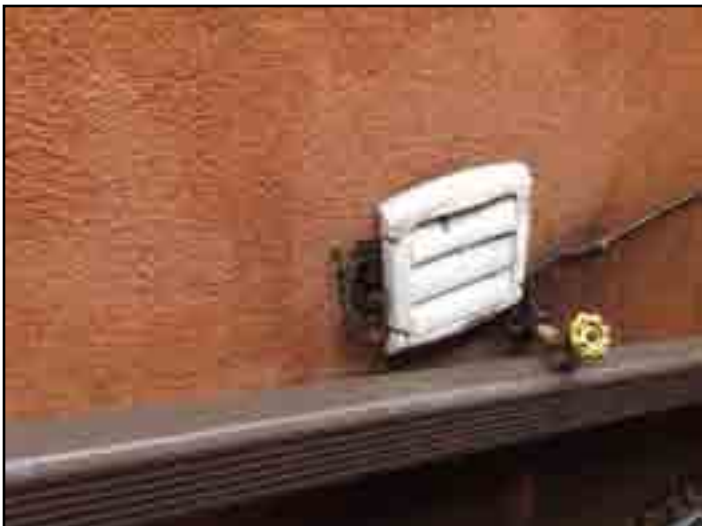
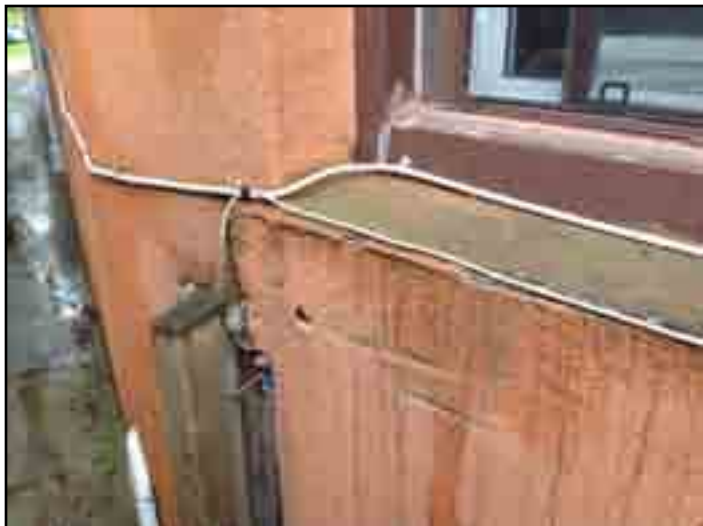
8. Condition: • [Mechanical damage](#)

Implication(s): Chance of water damage to contents, finishes and/or structure | Material deterioration

Location: Right Side

Task: Repair

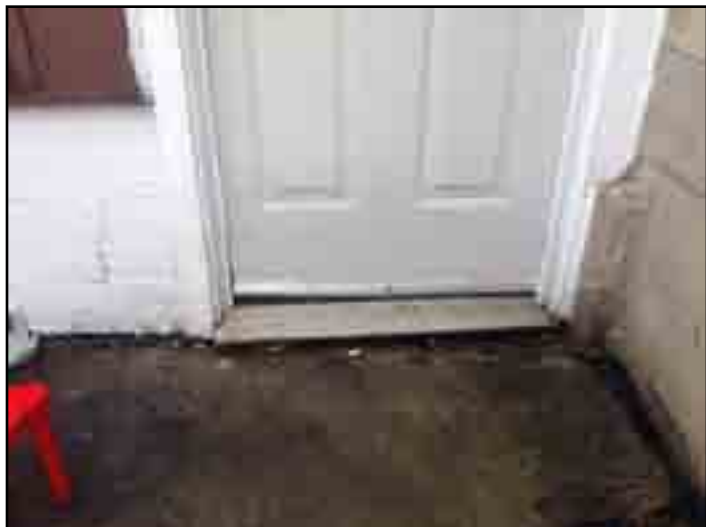
5.

11. Condition: • [Loose or poor fit](#)

Implication(s): Chance of damage to finishes and structure

Location: Rear Side

Task: Repair, reseal

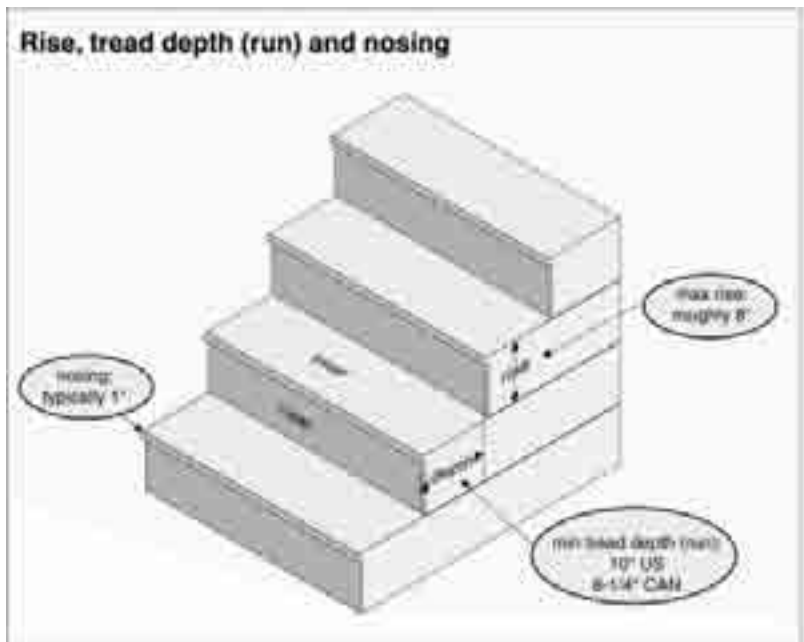
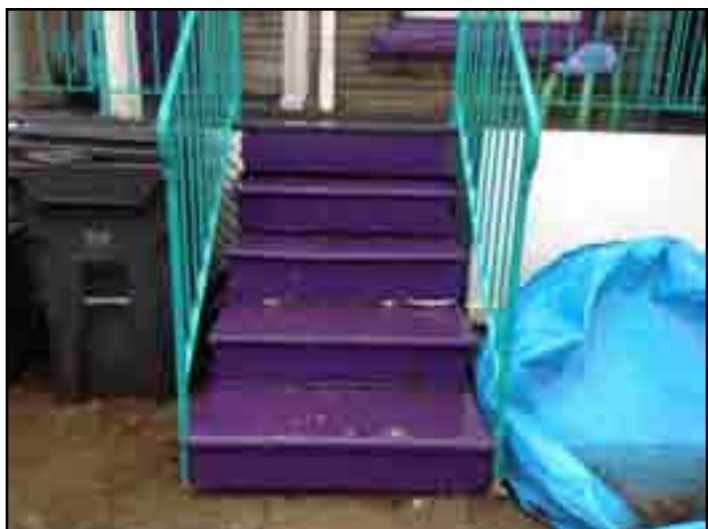
6.

12. Condition: • [Stair rise too big or not uniform](#)

Steps cracked also. (Repair)

Implication(s): Trip or fall hazard

Location: Front Exterior

Task: Adjust / Correct

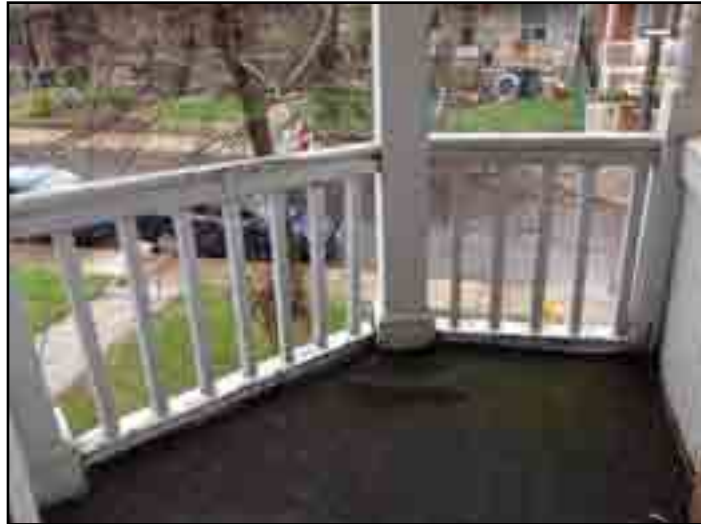
7.

13. Condition: • [Rot or insect damage](#)

Implication(s): Fall hazard

Task: Replace
Time: Immediate

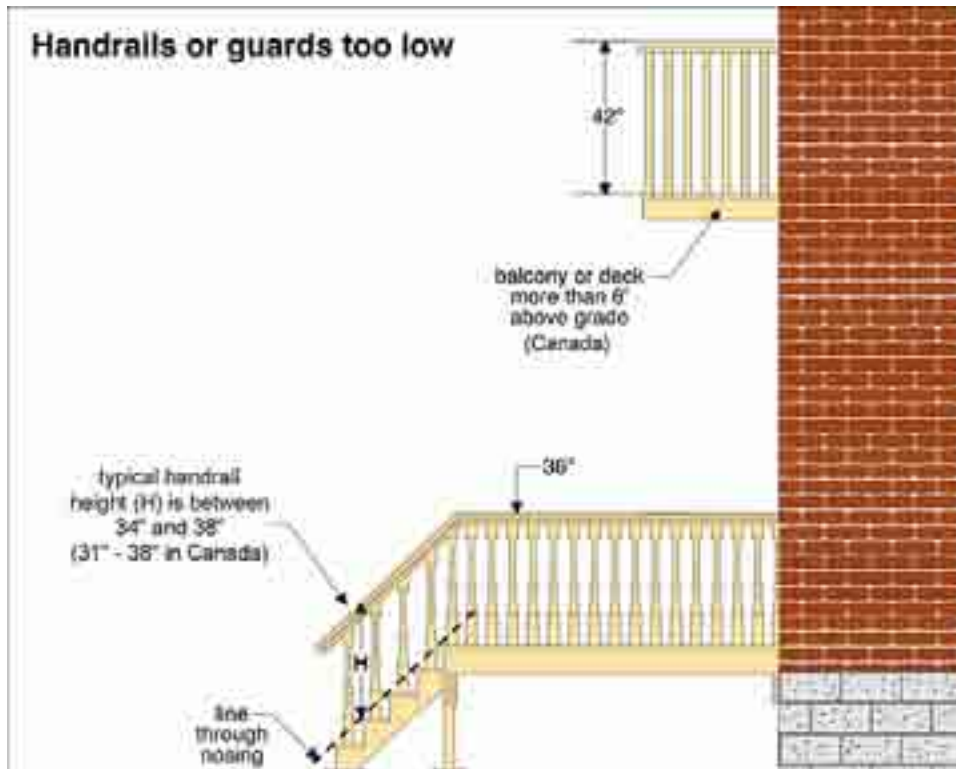
14. Condition: • [Too low](#)

Implication(s): Fall hazard

Location: Second Floor Balcony

Task: Replace

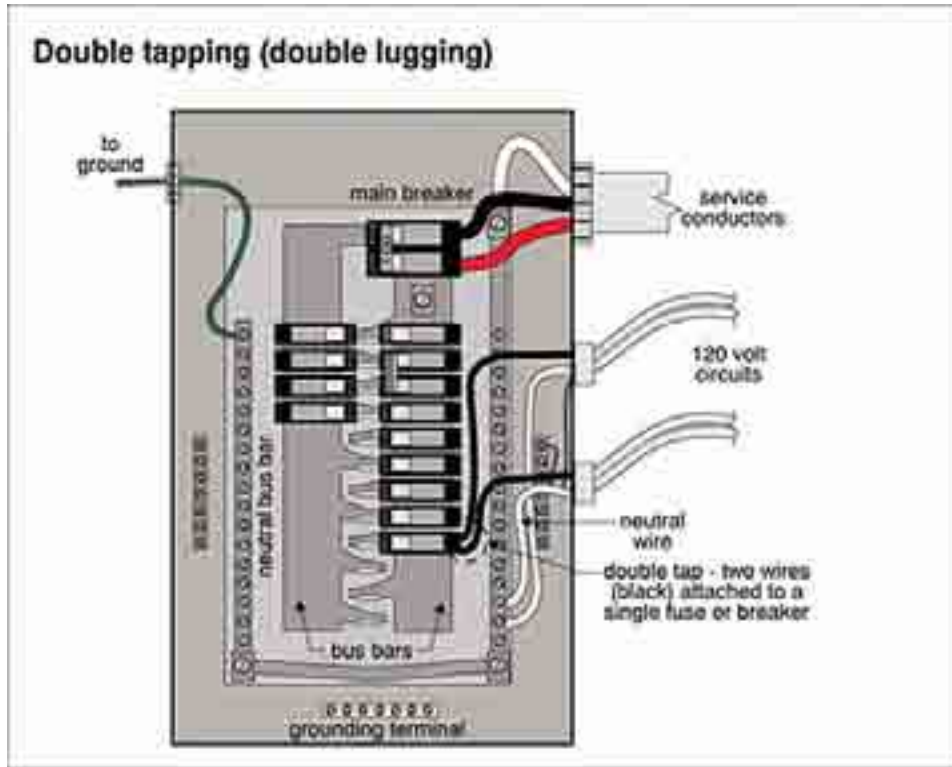
22. Condition: • [Double taps](#)

Implication(s): Fire hazard

Task: Further evaluation

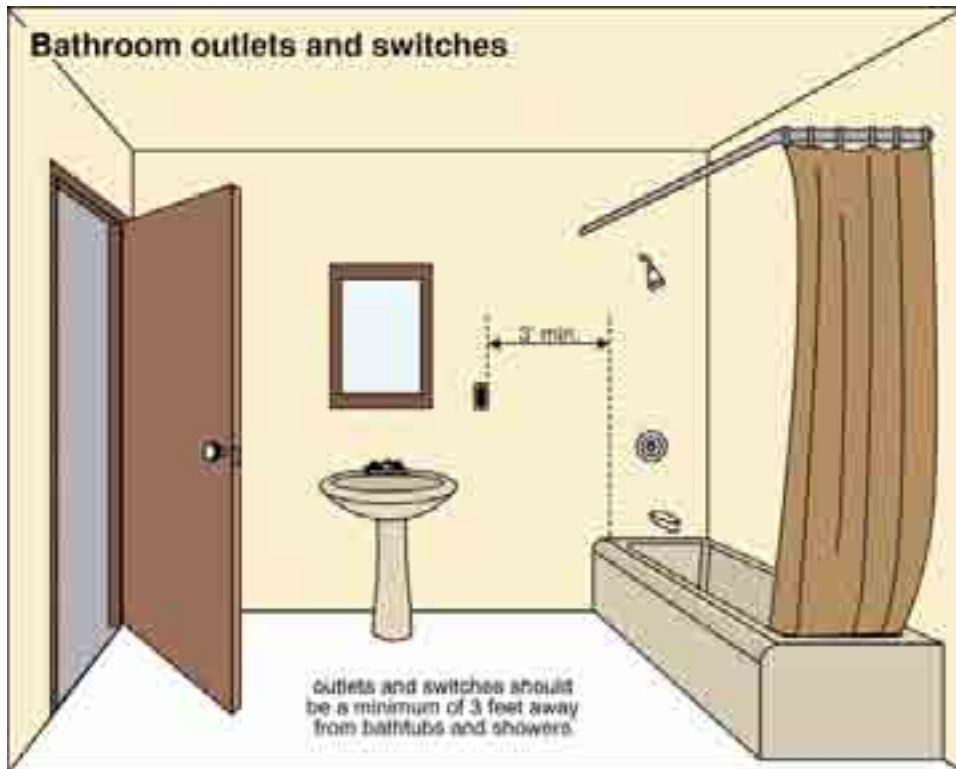
23. Condition: • [Location poor \(near Bath Tub or Shower Stall\)](#)

Implication(s): Electric shock

Task: Adjust / Correct

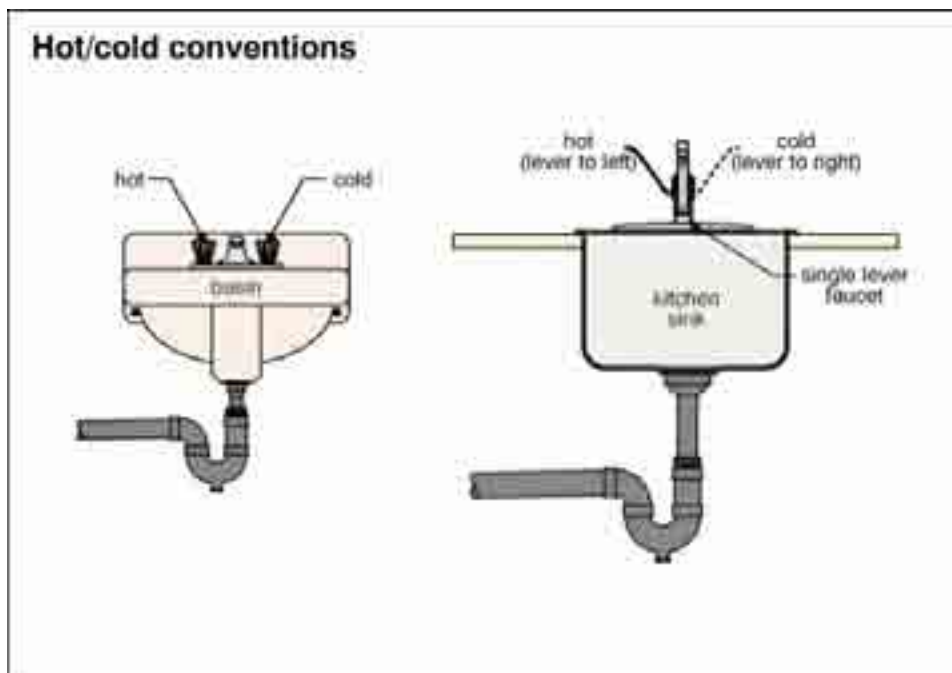
33. Condition: • [Hot and cold reversed](#)

Implication(s): Scalding

Location: First Floor Bathroom

Task: Adjust / Correct

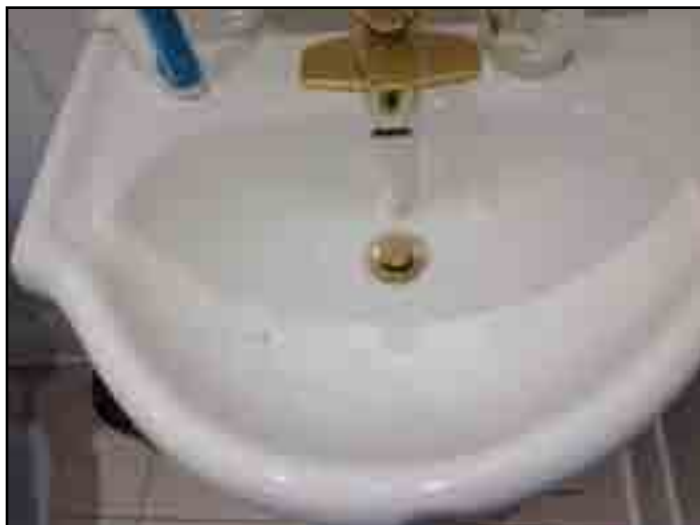
9.

34. Condition: • [Surface defects](#)

Cracked sink.

Implication(s): Hygiene issue

Location: Second Floor Bathroom

Monitor for any leaks.

Task: Monitor
Time: Ongoing

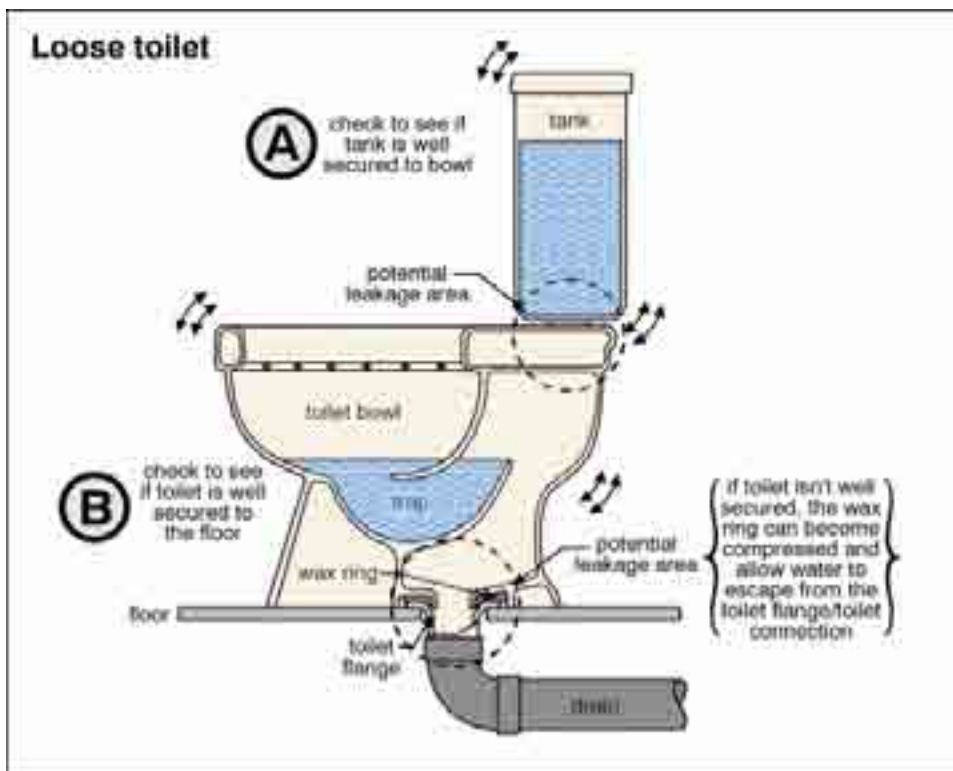
35. Condition: • [Loose](#)

Implication(s): Chance of water damage to contents, finishes and/or structure | Sewage entering the building

Location: Second Floor Bathroom

Task: Repair

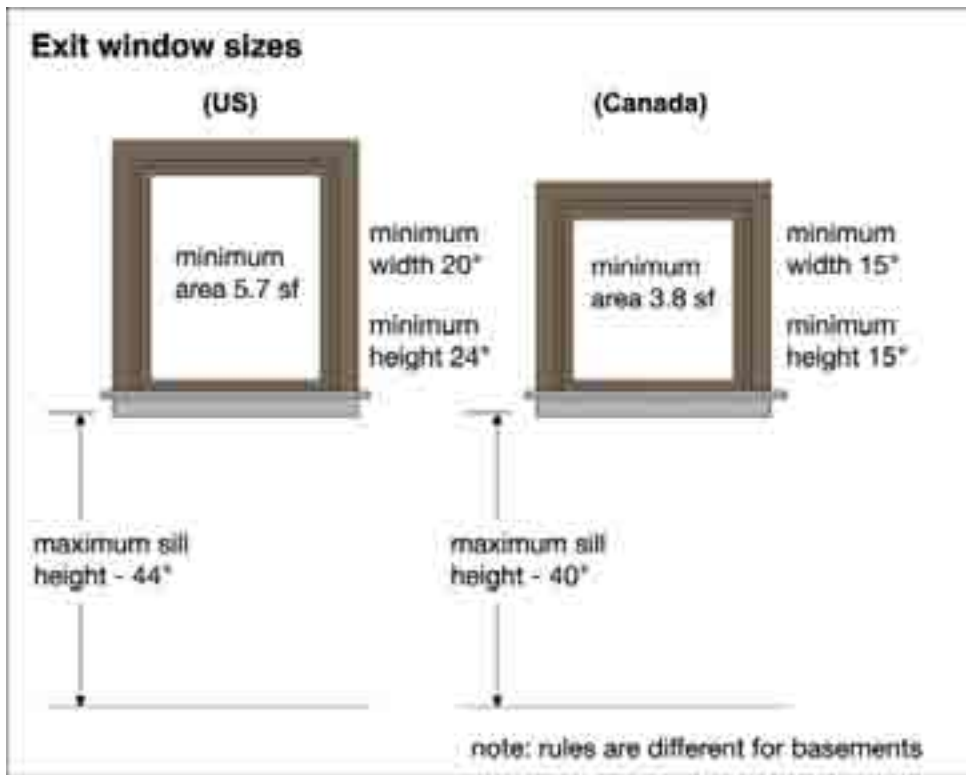
- 38. Condition:** • [Too small](#)
Implication(s): Restricted emergency exits
Location: Front Third Floor Bedroom
Task: Replace
Time: Immediate

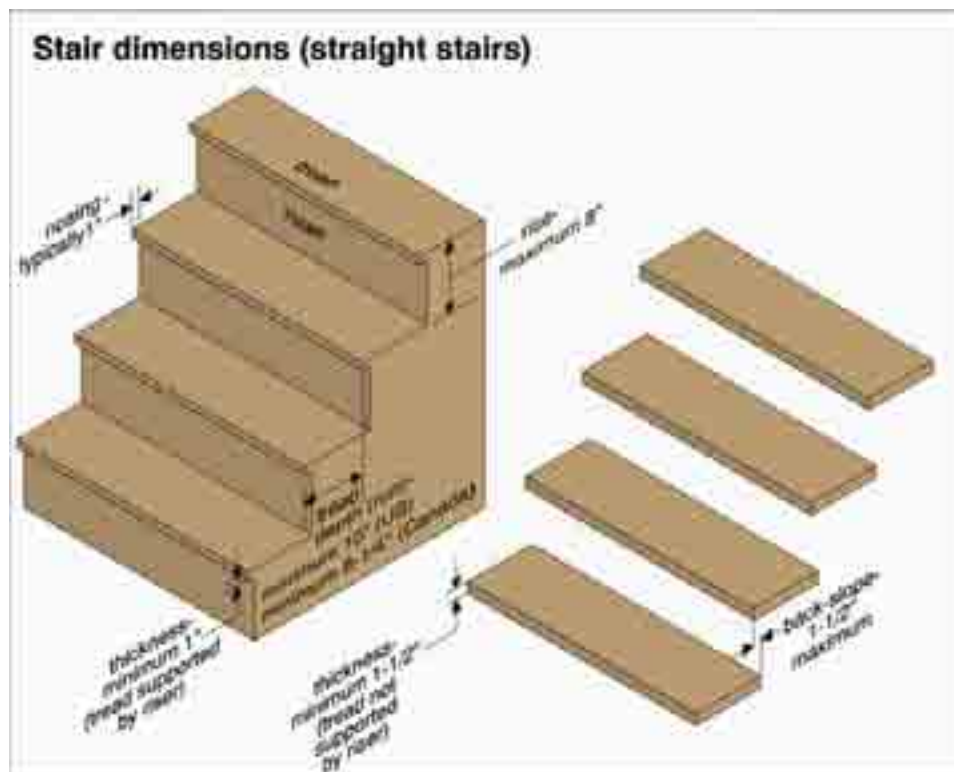
STAIRS \ Height**39. Condition:** • [Headroom - less than ideal](#)**Implication(s):** Physical injury**Task:** Adjust / Correct**STAIRS \ Treads****40. Condition:** • [Rise or run not uniform](#)**Implication(s):** Trip or fall hazard**Location:** Rear Side Basement, and second floor.**Task:** Adjust / Correct**Time:** Immediate**41. Condition:** • [Rise excessive](#)**Implication(s):** Trip or fall hazard**Location:** Rear Side Basement, and second floor.**Task:** Adjust / Correct**Time:** Immediate

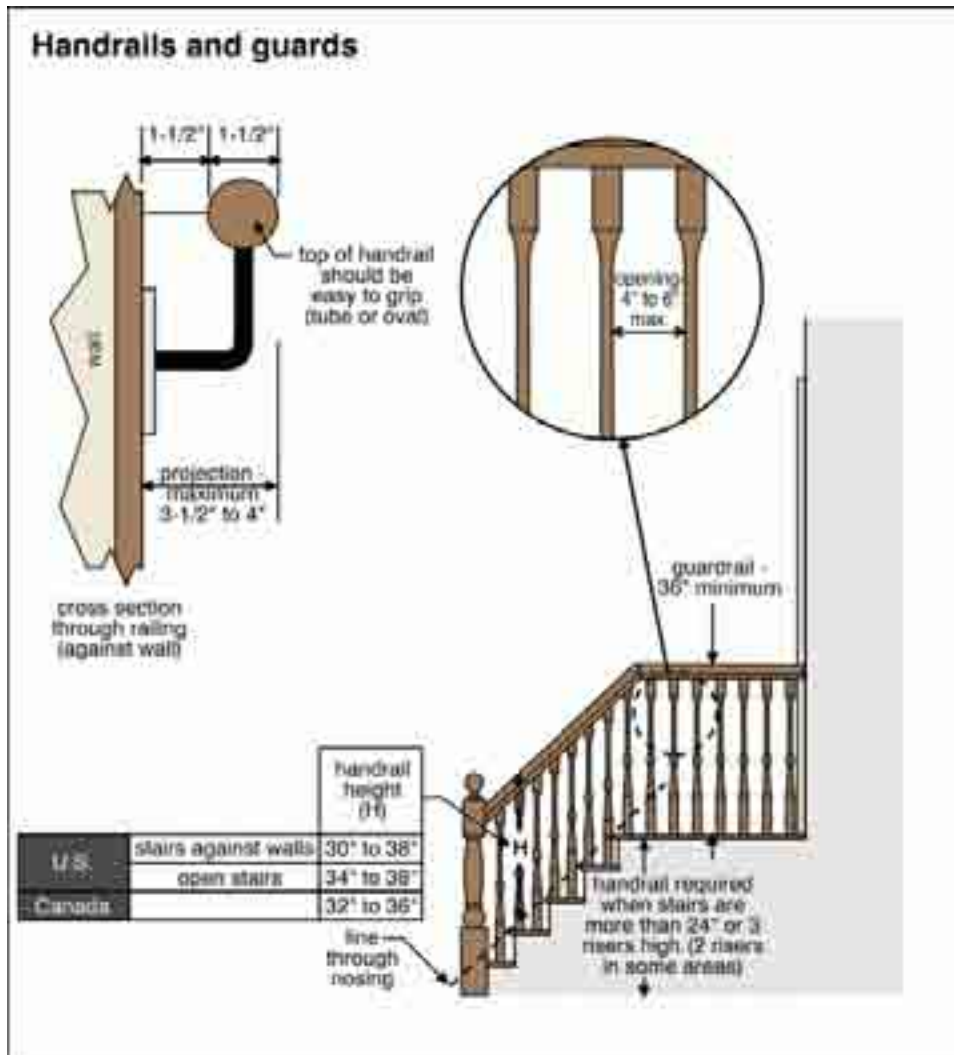
43. Condition: • [Missing](#)

Implication(s): Fall hazard

Task: Install / Add New (as needed)

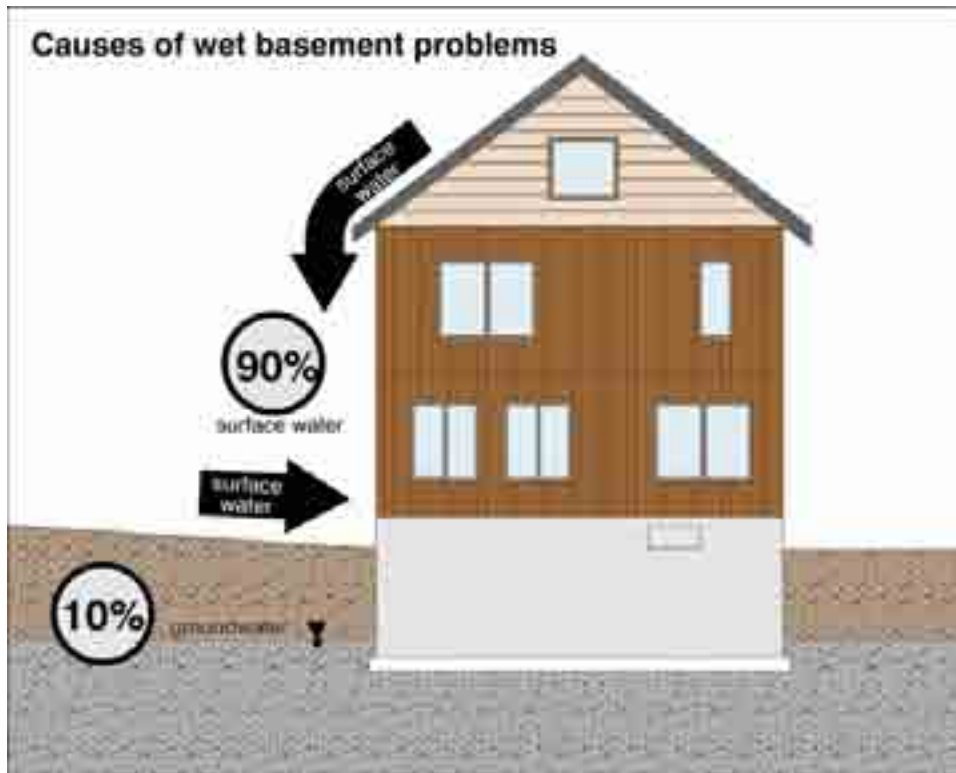
45. Condition: • [Poor gutters and downspouts](#)

Implication(s): Chance of water damage to contents, finishes and/or structure

Task: Adjust / Correct
