# INSPECTION REPORT

For the Property at:  
**495 CRAWFORD ST**  
TORONTO, ON M6G 3J9

Inspection Date: Tuesday, May 8, 2018

Lighthouse Inspections  
2325 Hurontario Street, Suite 322  
Mississauga, ON L5A 4K4  
416-453-4192  
905-271-6381

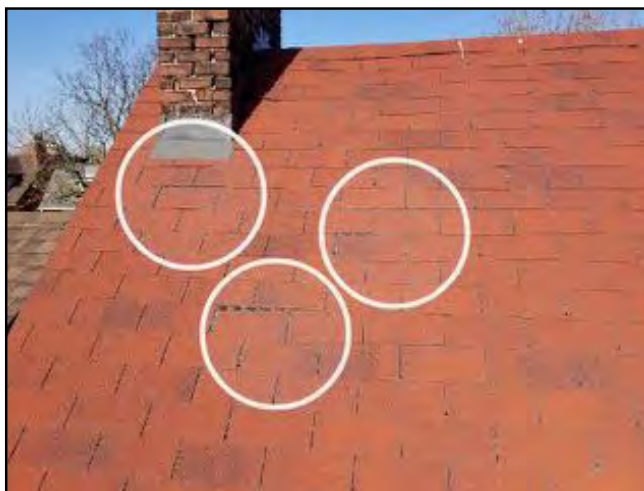
**1. Condition:** • [Missing, loose or torn](#)

Resecure some minor loose shingles

**Implication(s):** Chance of water damage to contents, finishes and/or structure

**Location:** Rear Side

1. Missing, loose or torn

**Task:** Repair

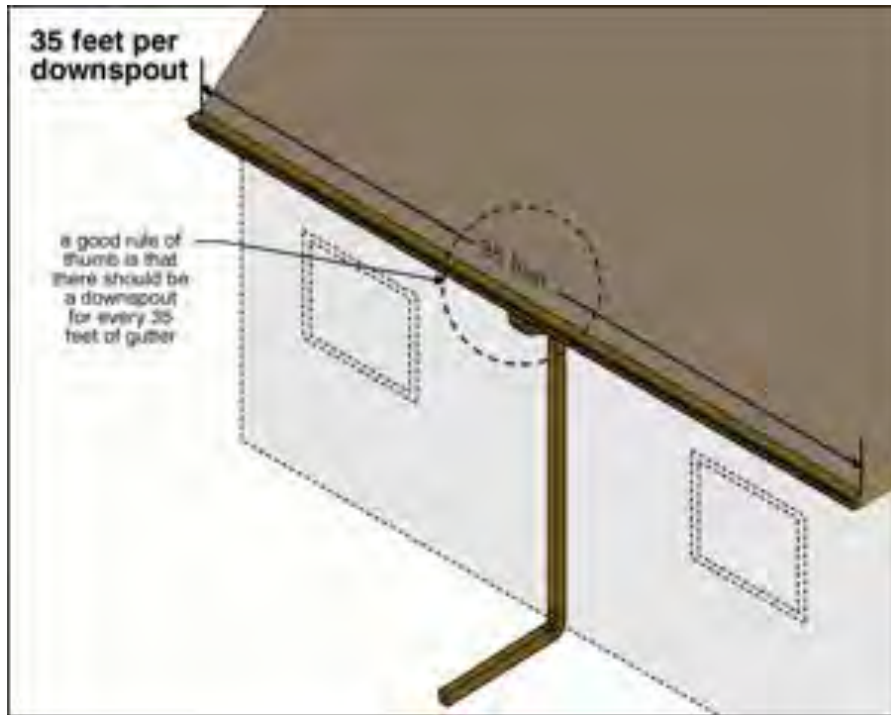
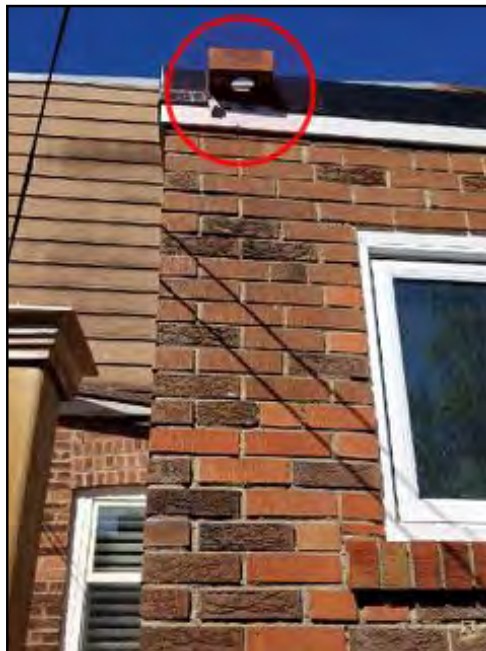
**2. Condition:** • [Missing](#)

**Implication(s):** Chance of water damage to contents, finishes and/or structure

**Location:** Rear Side

2. Missing

**Task:** Install / Add New (as needed)

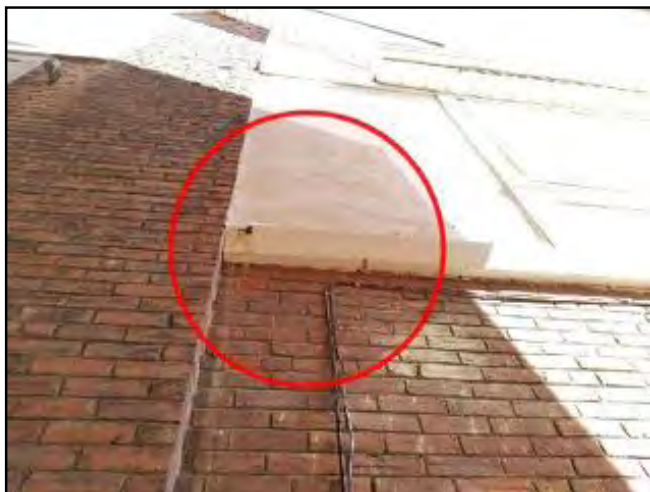
3. Condition: • [Loose](#)

**Implication(s):** Chance of water damage to contents, finishes and/or structure

**Location:** Various

3. Loose

Resecure and seal around any loose trim

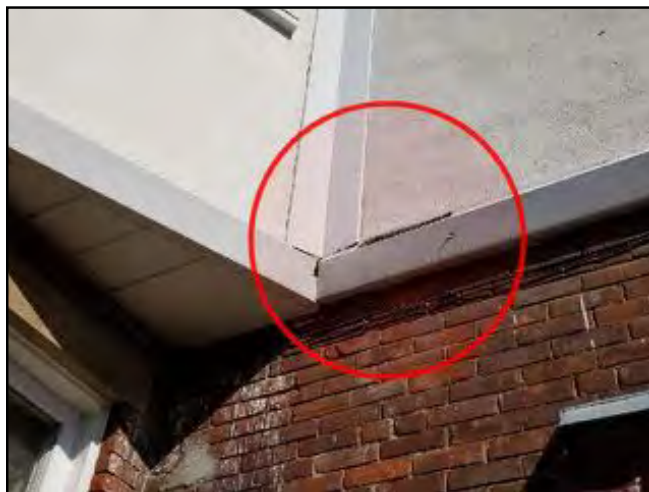
4. Loose

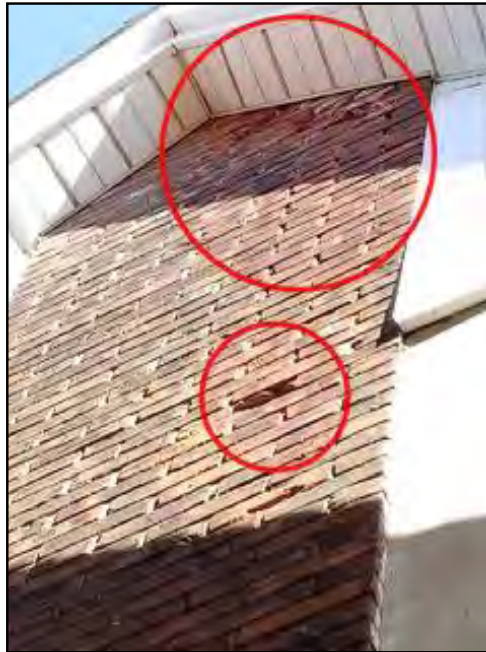
4. Condition: • [Masonry deterioration](#)

**Implication(s):** Weakened structure | Chance of structural movement

**Location:** Right Side

5. Masonry deterioration

**Task:** Repair

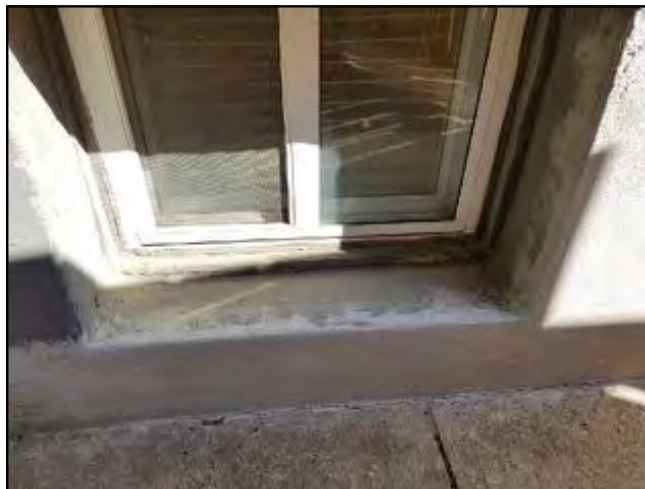
5. Condition: • [Paint or stain needed](#)

Implication(s): Chance of water damage to contents, finishes and/or structure | Material deterioration

Location: Right Side Basement

6. Paint or stain needed

Task: Reseal

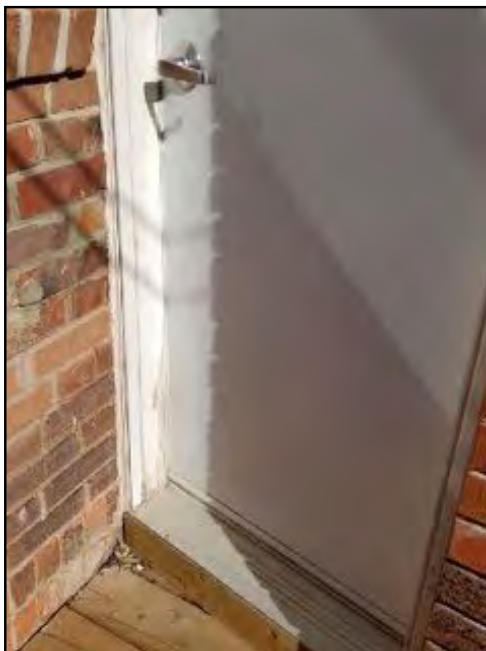
**6. Condition:** • [Paint or stain needed](#)

**Implication(s):** Material deterioration | Chance of damage to finishes and structure

*7. Paint or stain needed*

**Task:** Reseal

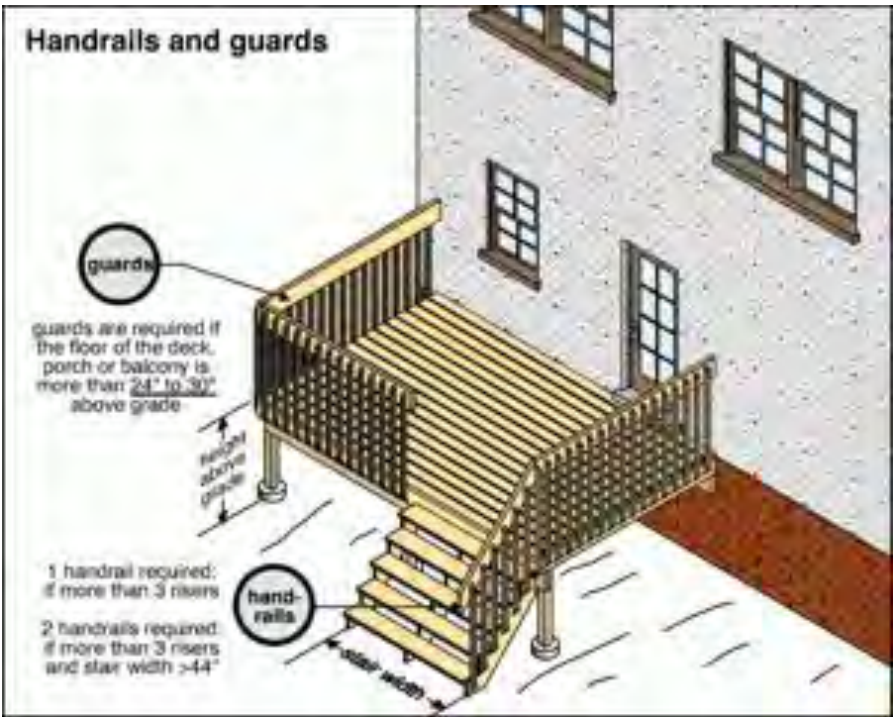
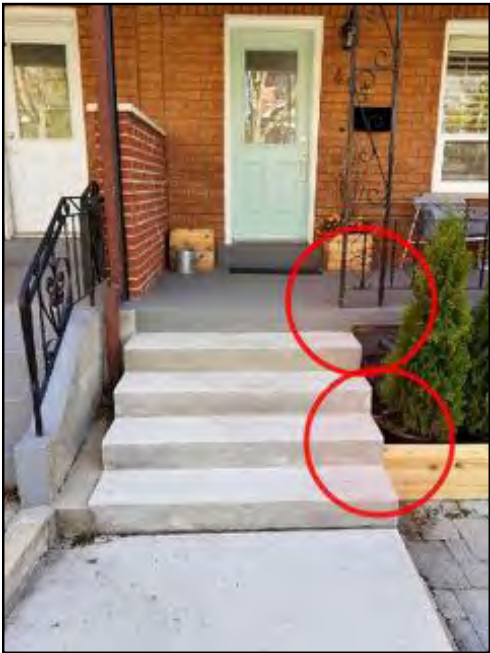
**7. Condition:** • [Missing](#)

**Implication(s):** Fall hazard

**Location:** Front Porch & Rear Deck

8. Missing

**Task:** Install / Add New (as needed)

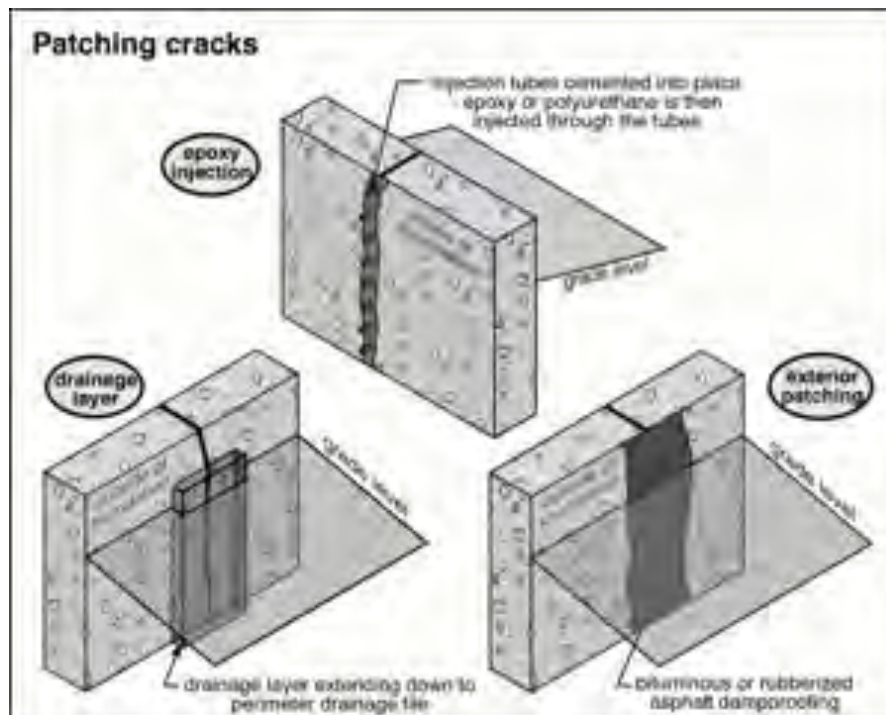
**8. Condition:** • Typical minor cracks

**Implication(s):** Chance of water entering building

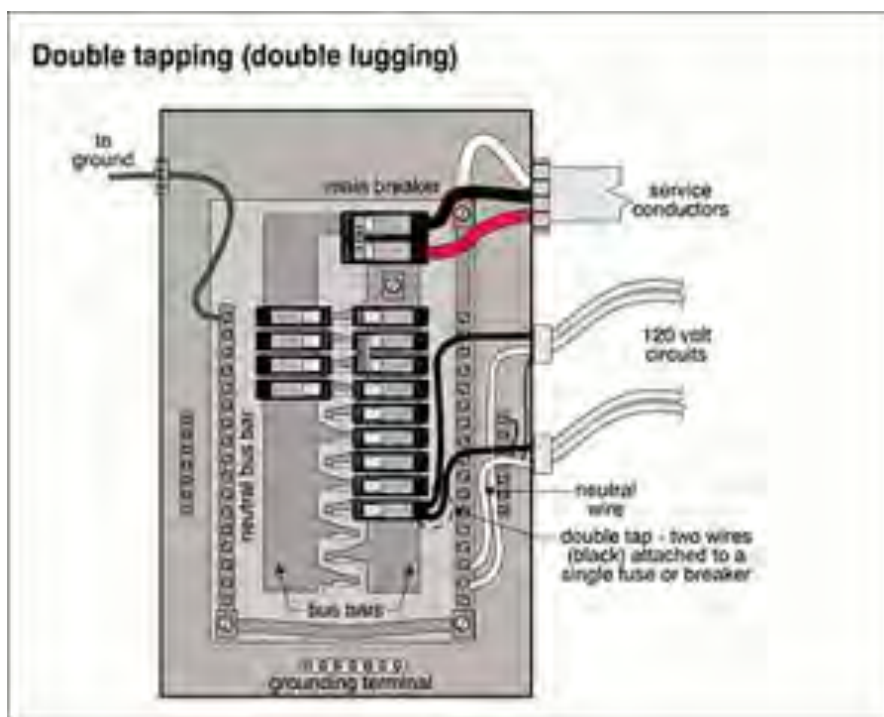
**10. Condition:** • [Double taps](#)

**Implication(s):** Fire hazard

**Task:** Adjust / Correct

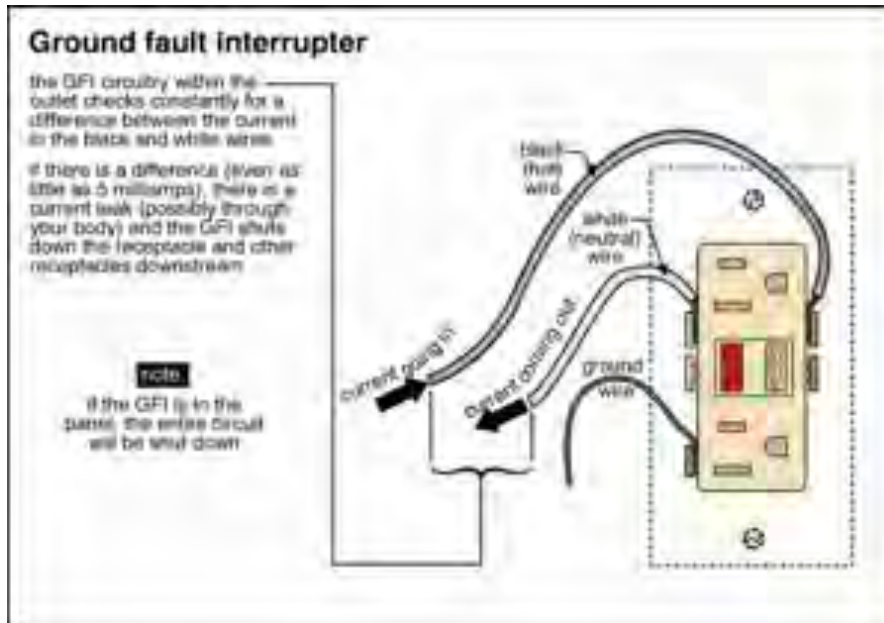
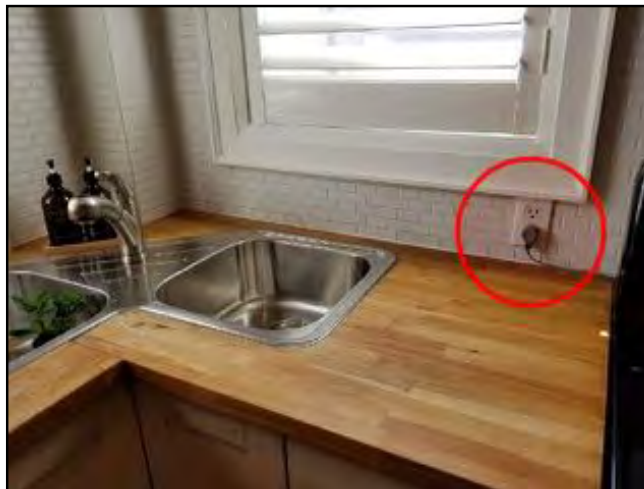
**11. Condition:** • [GFCI/GFI needed \(Ground Fault Circuit Interrupter\)](#)

**Implication(s):** Electric shock

**Location:** Laundry Area, kitchen

11. GFCI/GFI needed (Ground Fault Circuit...

**Task:** Install / Add New (as needed)

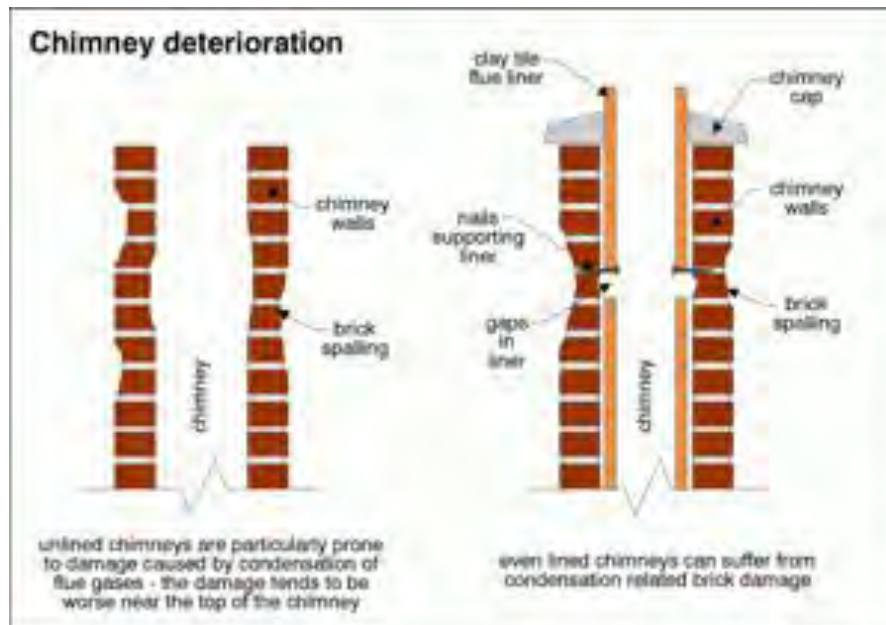
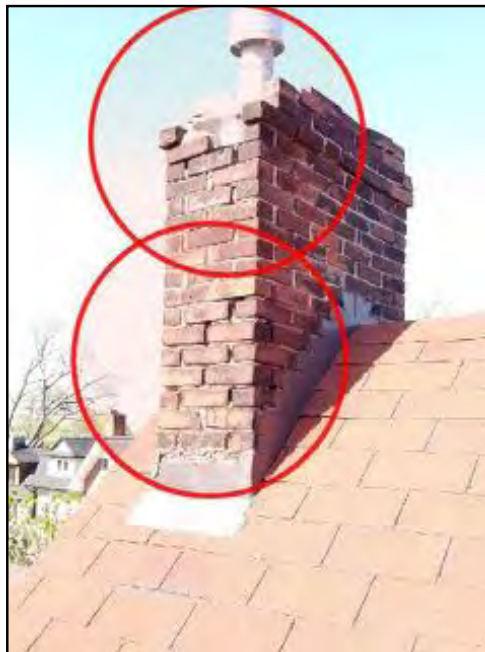
**15. Condition:** • [Loose, missing or deteriorated mortar](#)

**Implication(s):** Material deterioration

12. Loose, missing or deteriorated mortar

**Task:** Repair

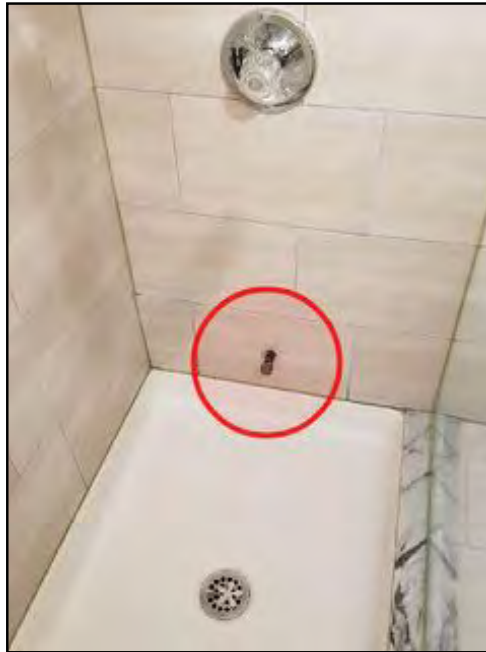
**16. Condition:** • Missing

Missing spout at shower. (Install if wanted) Remove metal pipe.

**Implication(s):** No water

**Location:** Basement Bathroom

14. Missing

**Task:** Install / Add New (as needed)

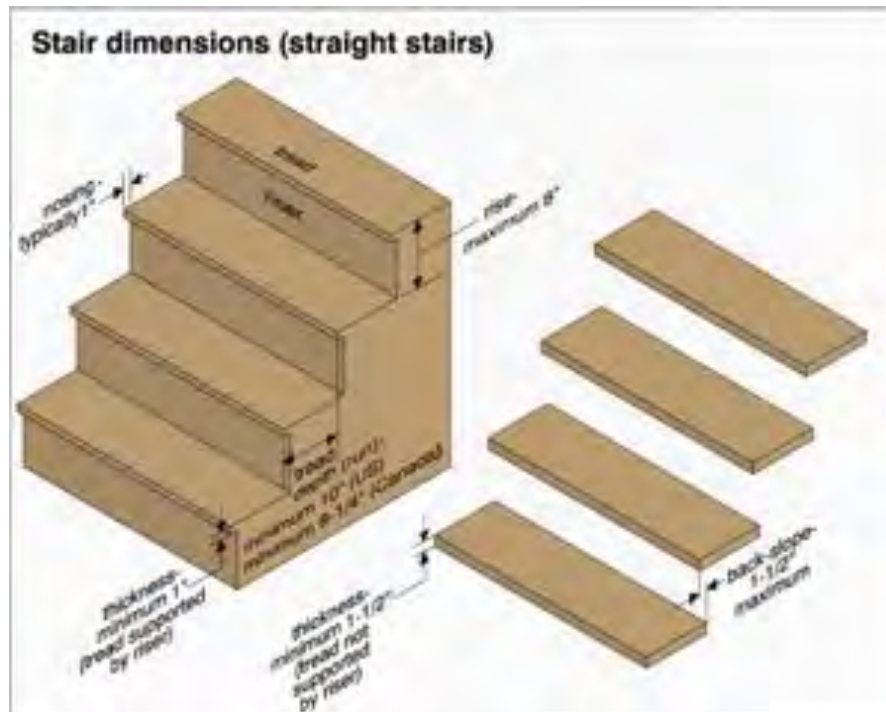
19. Condition: • [Rise or run not uniform](#)

Implication(s): Trip or fall hazard

Location: Second Floor Staircase

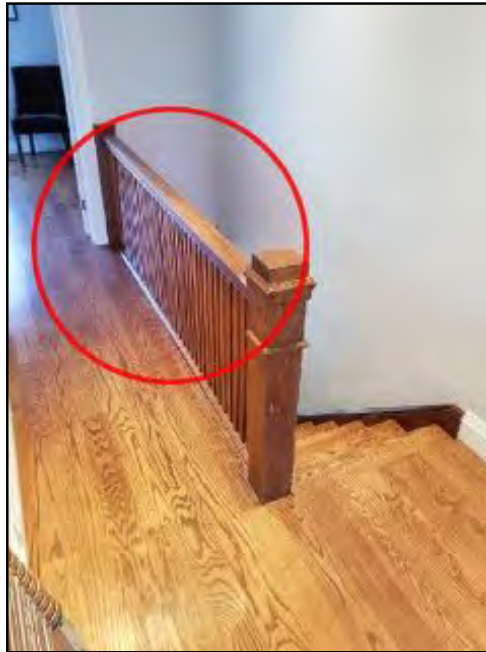
21. Condition: • [Too low](#)

Implication(s): Fall hazard

20. Too low
