# INSPECTION REPORT

For the Property at:  
**81A BEACONSFIELD AVE**  
TORONTO, ON M6J 3J3

Prepared for: ANDREW NICHOLSON  
Inspection Date: Friday, September 21, 2018  
Prepared by: Michael Tita

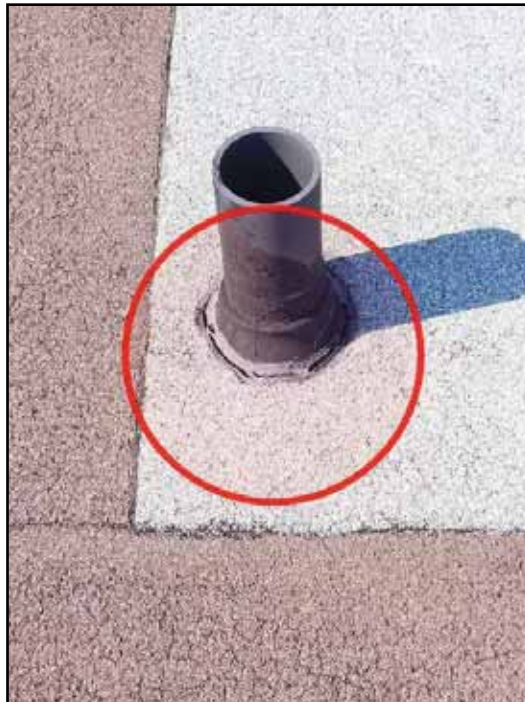
- 1. Condition: • Loose
- Task: Reseal
- Time: Immediate
- Cost: Minor

1. Loose

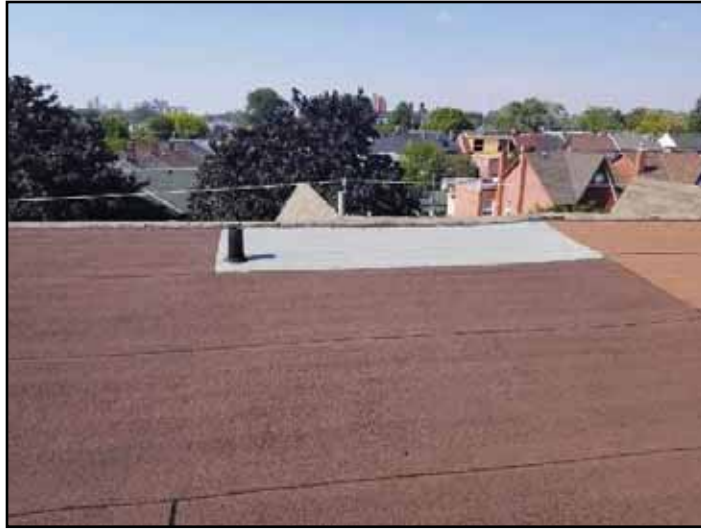
- 2. Condition: • [Patched](#)
- Location: Top Floor Roof
- Task: Monitor
- Time: Ongoing

2. Patched

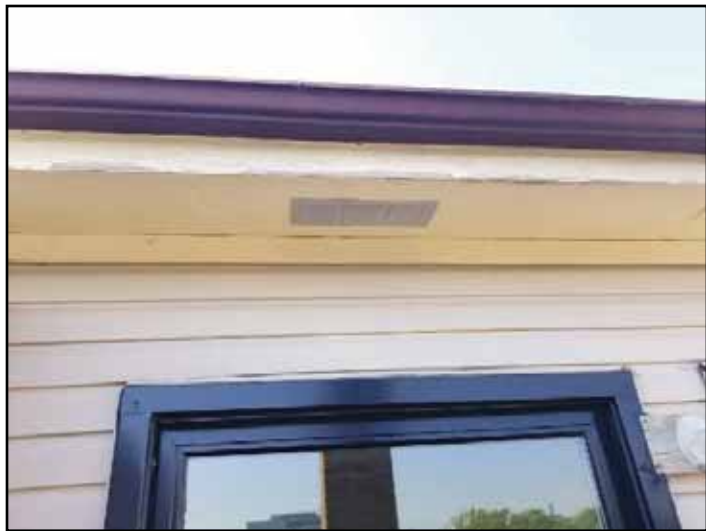
- 3. Condition:** • Paint - deteriorated / missing
- Location:** Rear Side
- Task:** Reseal
- Time:** Less than 1 year
- Cost:** Regular maintenance item

3. *Paint - deteriorated / missing*

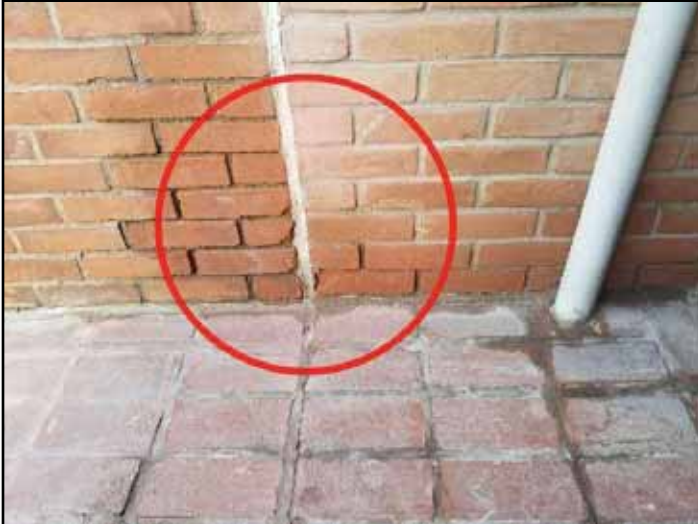
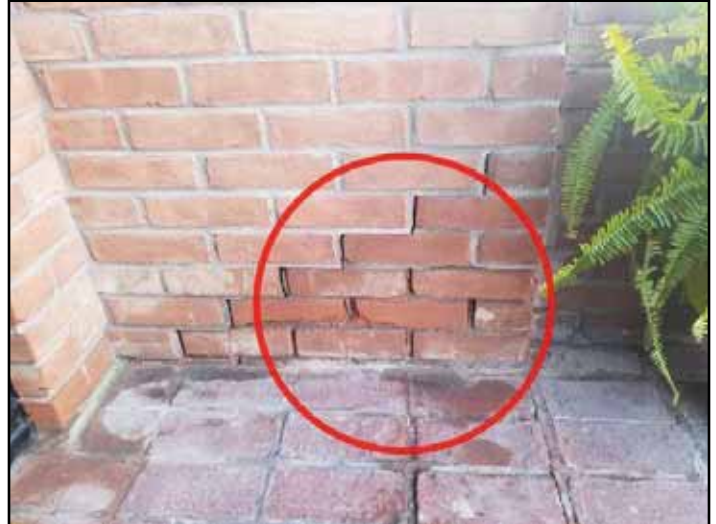
4. Condition: • [Masonry deterioration](#)

Location: Front various

4. Masonry deterioration

5. Masonry deterioration

Task: Repair

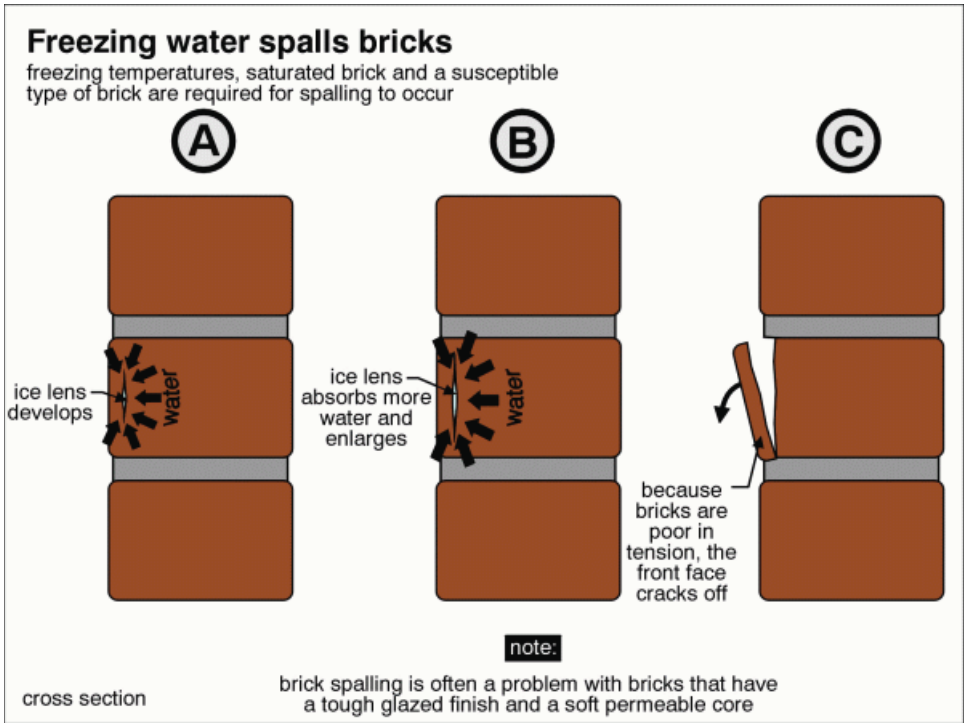
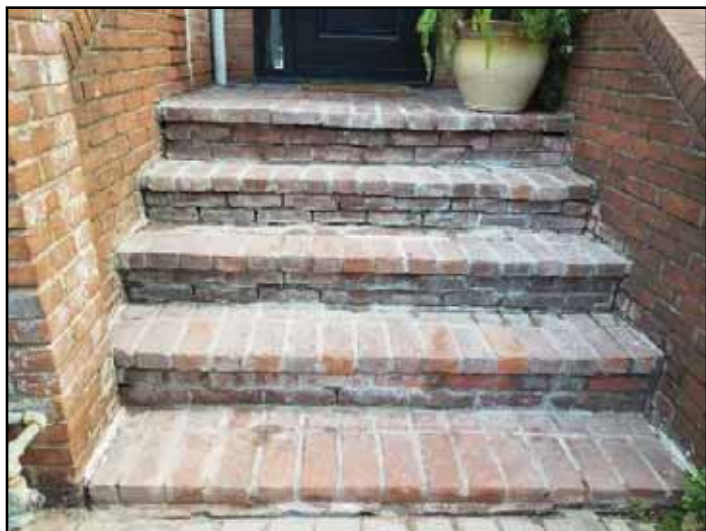
5. Condition: • [Masonry or concrete spalling](#)

Location: Front Porch

6. Masonry or concrete spalling

Task: Repair

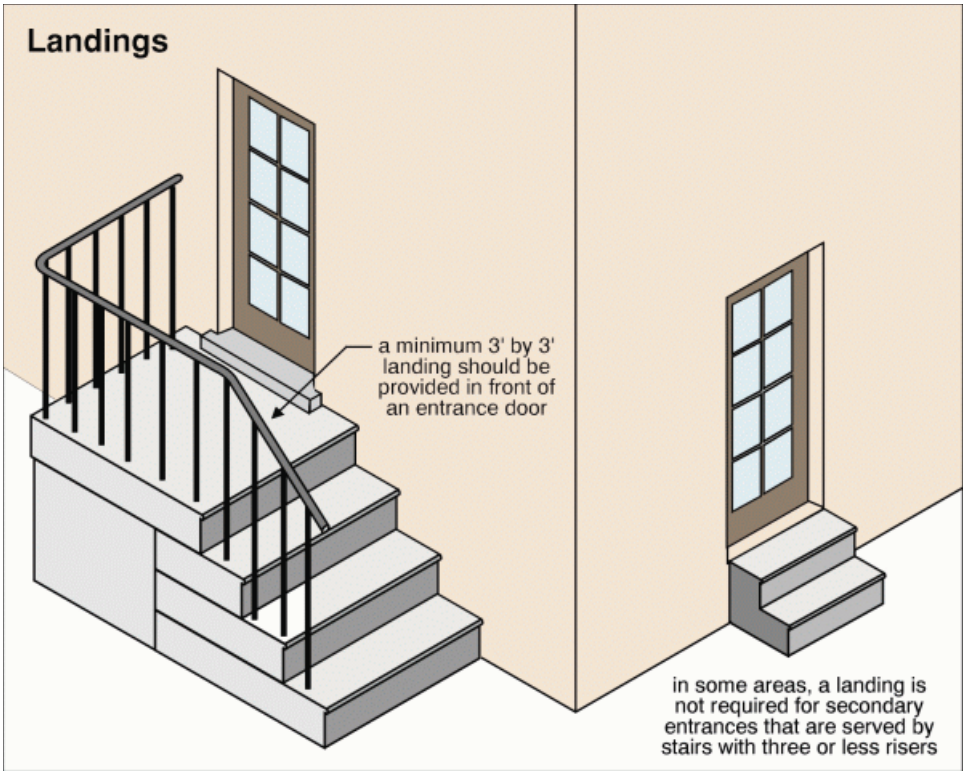
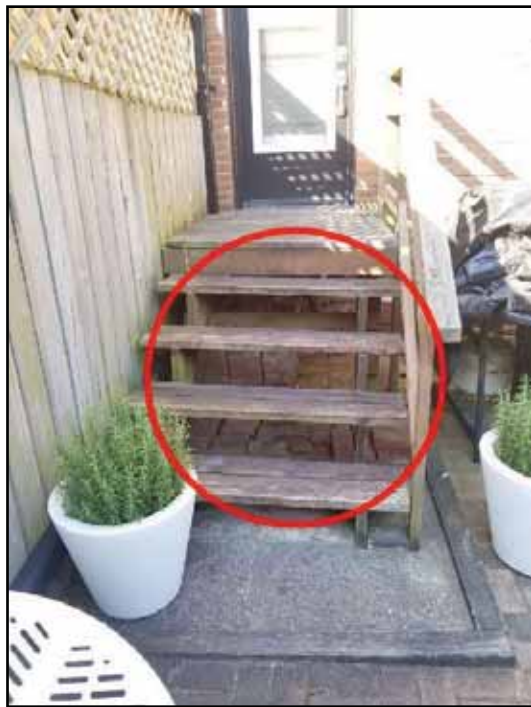
**6. Condition:** • [Steps slope](#)  
**Location:** Rear Side  
**Task:** Repair or replace  
**Time:** Discretionary

7. Steps slope

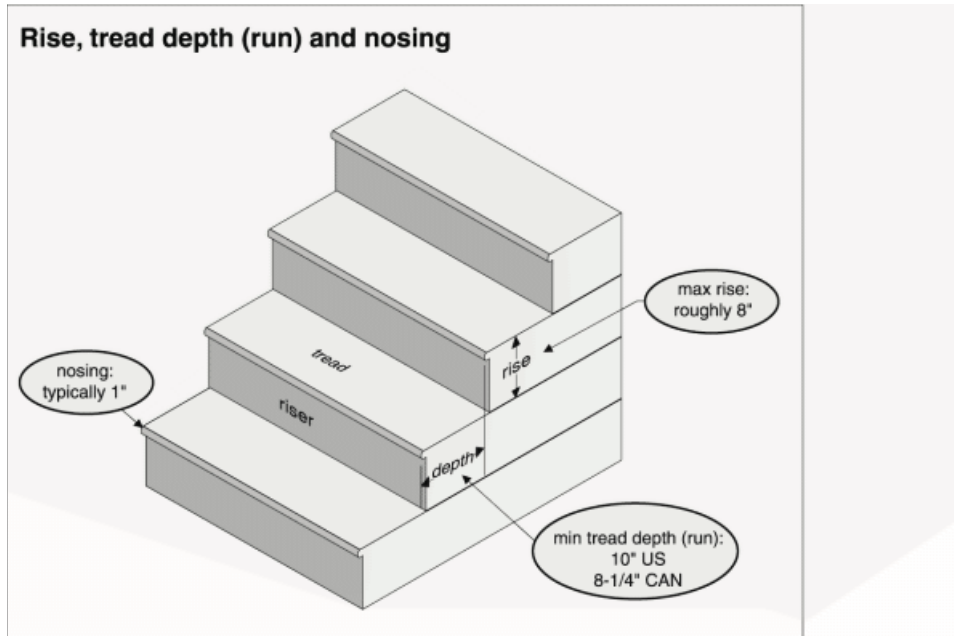
**7. Condition:** • [Stair rise too big or not uniform](#)

Top step slightly too high and uneven risers.

**Location:** Front Porch  
**Task:** Adjust / Correct  
**Time:** Discretionary

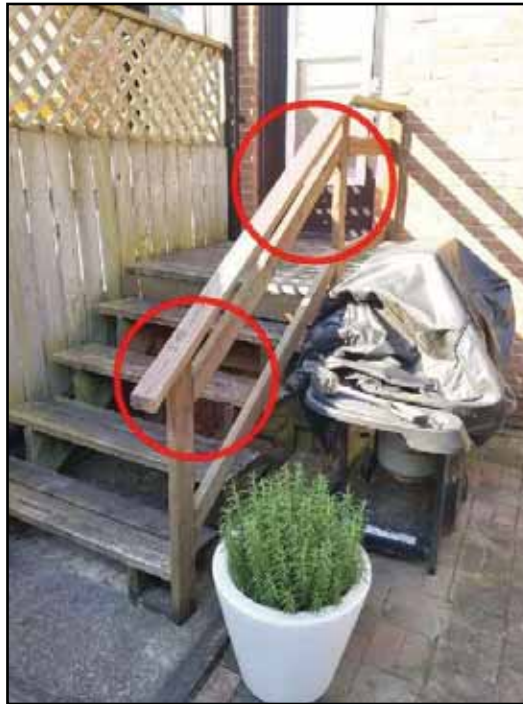
**8. Condition:** • [Loose](#)

**Location:** Rear Side

8. Loose

**Task:** Repair or replace

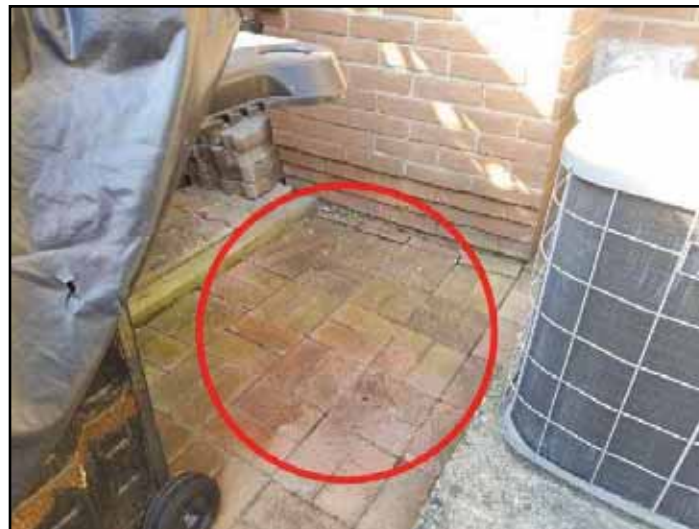
**9. Condition:** • Low spot(s) in grading. Should be addressed in order to avoid water pooling or draining near the foundation, which could lead to moisture penetration in the foundation.

9. Low spot(s) in grading. Should be addressed...

**Task:** Adjust / Correct

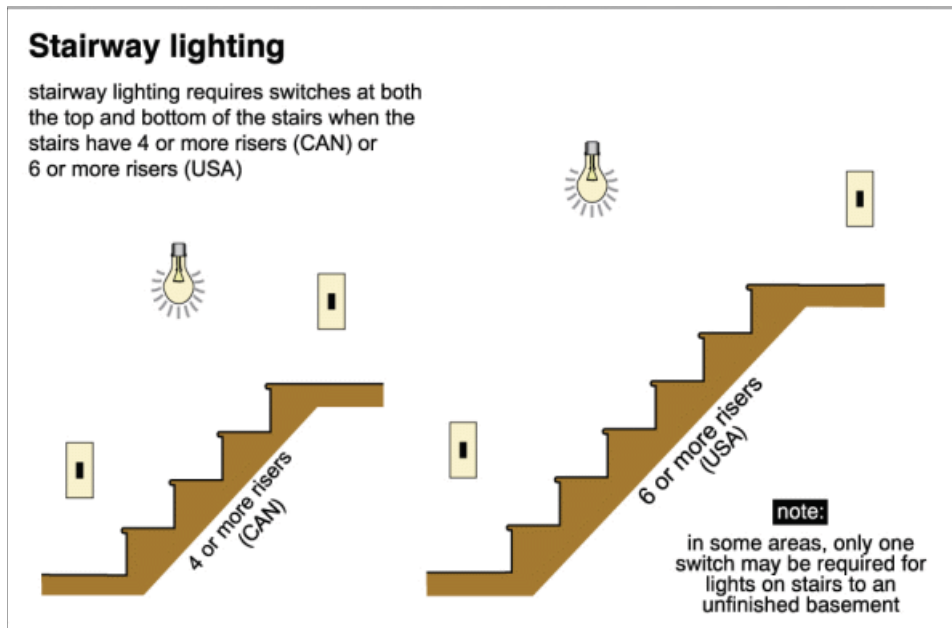
**11. Condition:** • 3-way not working as intended

**Location:** Second Floor Staircase

**Task:** Adjust / Correct

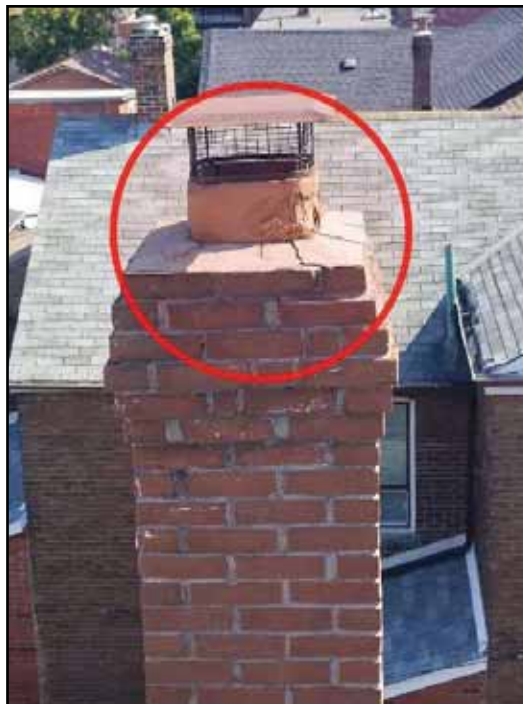
**16. Condition:** • Damaged, cracked or deteriorated flue or liner. Repair or replace as needed.

12. Damaged, cracked or deteriorated flue or...

**Task:** Further evaluation

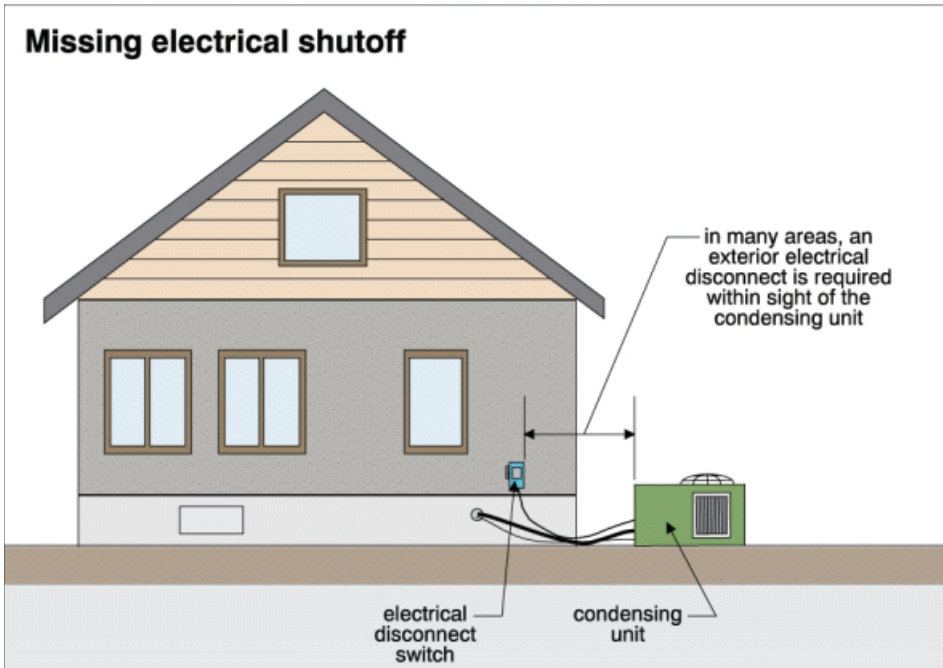
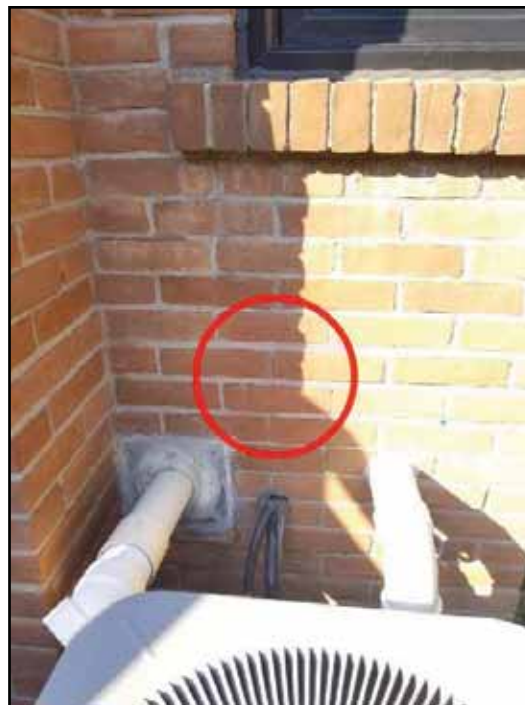
18. **Condition:** • [Missing electrical shutoff](#)

(Should have)

**Location:** Rear Side Exterior Wall

14. Missing electrical shutoff

Recommend adding

**Task:** Install / Add New (as needed)

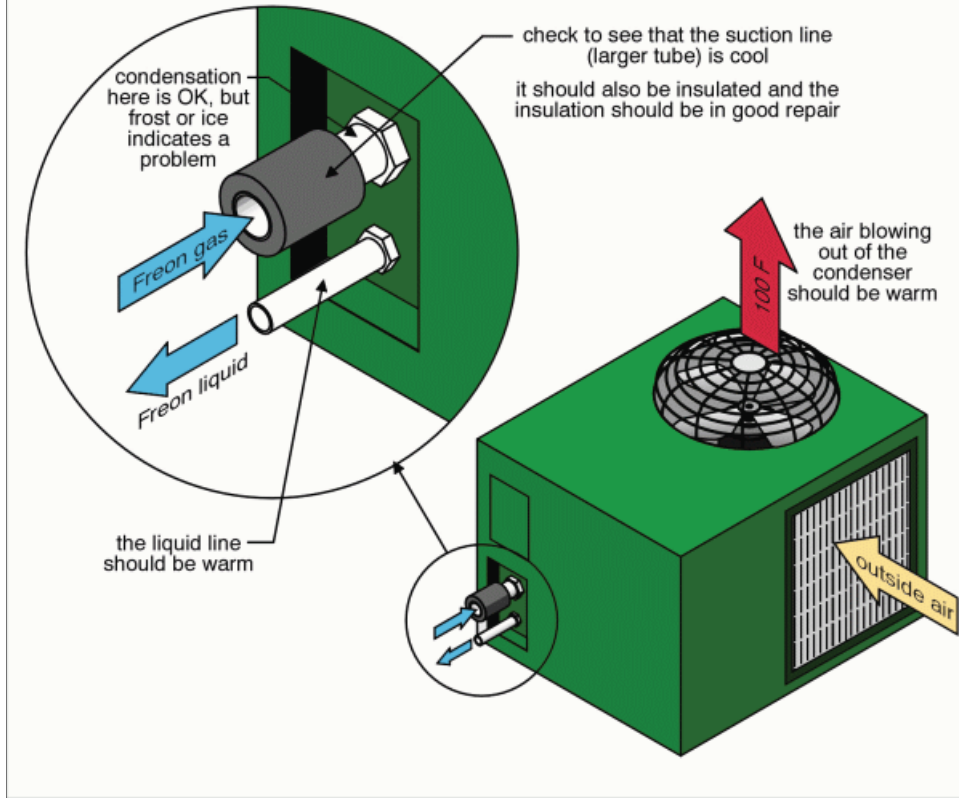
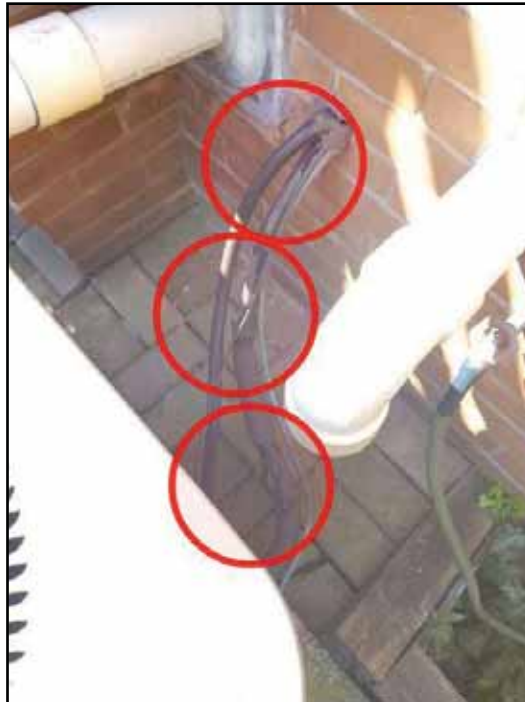
19. Condition: • [Insulation - missing](#)

15. Insulation - missing

Task: Replace

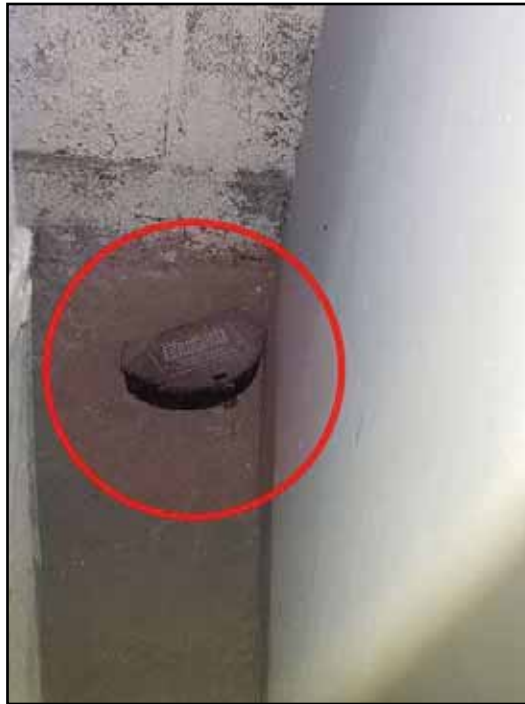
20. • Evidence of previous pest/ rodent issues, possibly ongoing.

(Traps noted)

**Location:** Basement Garage

21. Evidence of previous pest/ rodent issues,...

(Further evaluation recommended.)

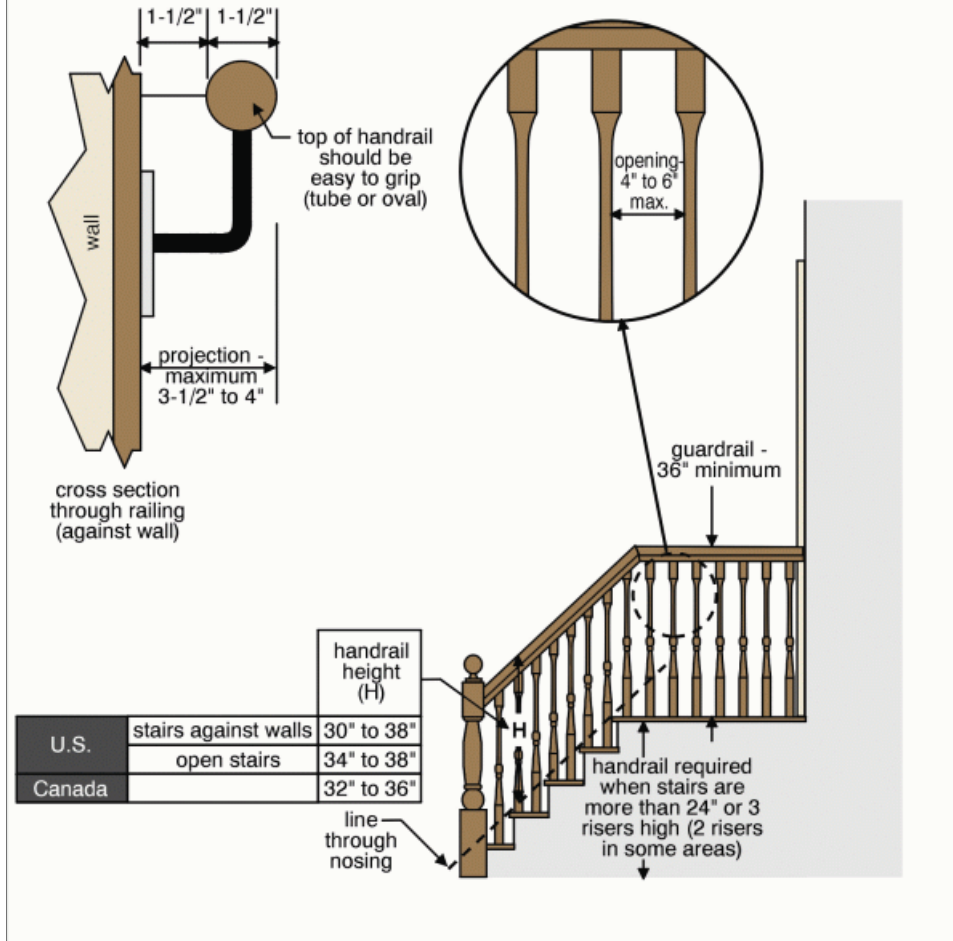
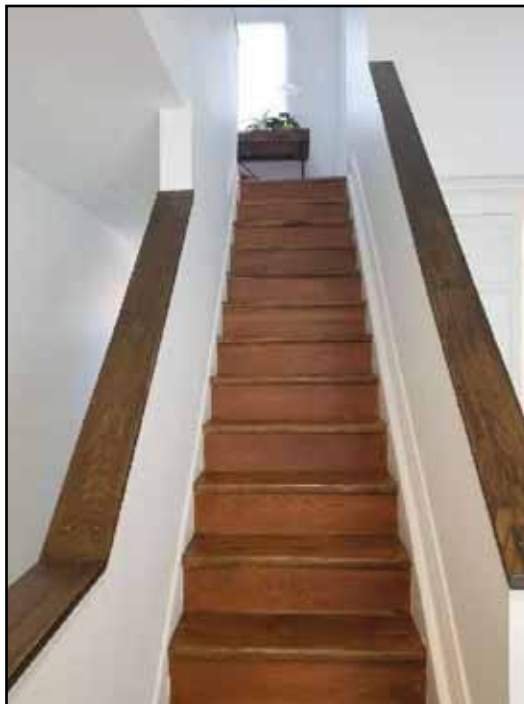
**21. Condition:** • [Missing](#)

**Location:** Second & Top Floor Staircases

22. Missing

**Task:** Install / Add New (as needed)

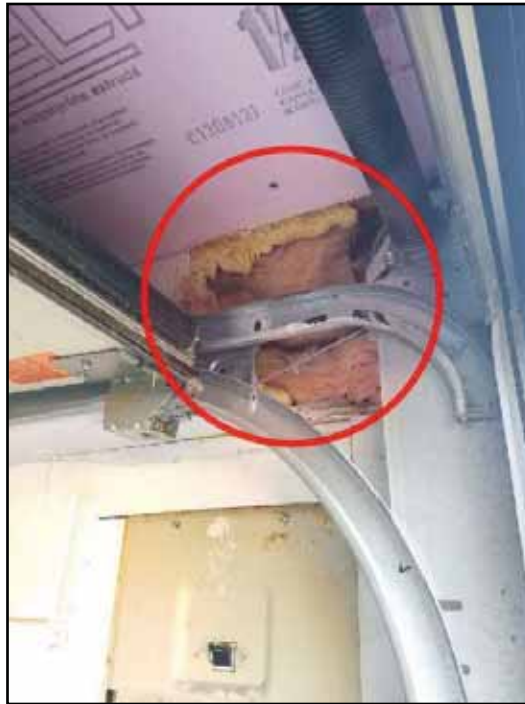
**24. Condition:** • Gaps or cutouts in walls or ceilings need to be sealed.

**Location:** Garage

23. Gaps or cutouts in walls or ceilings need t...

**Task:** Repair
