INSPECTION REPORT

For the Property at:
104 EDITH DR
TORONTO, ON M4R 1Z2

Prepared for: ANDREW NICHOLSON and HEATHER SHAW
Inspection Date: Thursday, January 31, 2019
Prepared by: Michael Tita

Report No. 1856

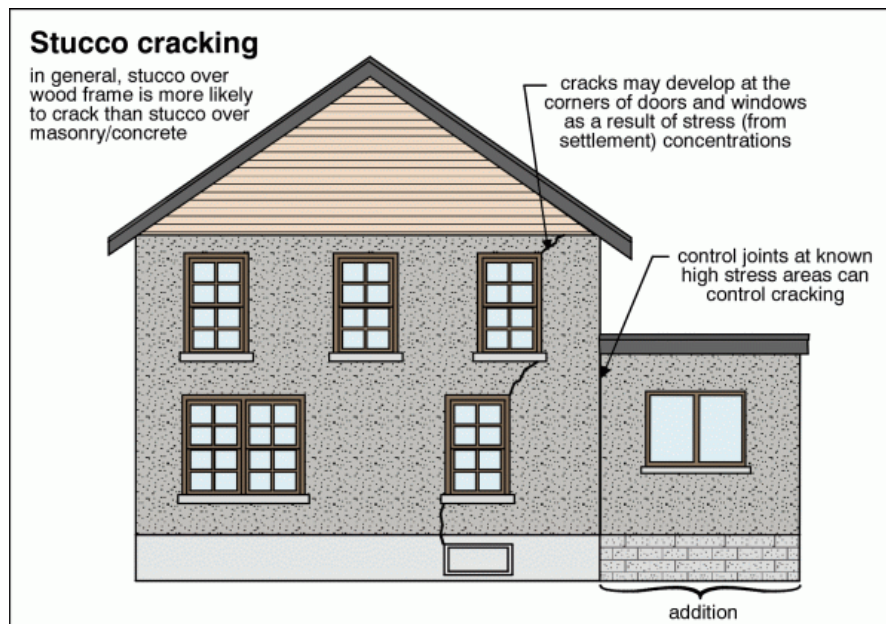
2. Condition: • [Cracked](#)

(Typical minor cracks)

Location: Front entry & rear addition

Task: Repair

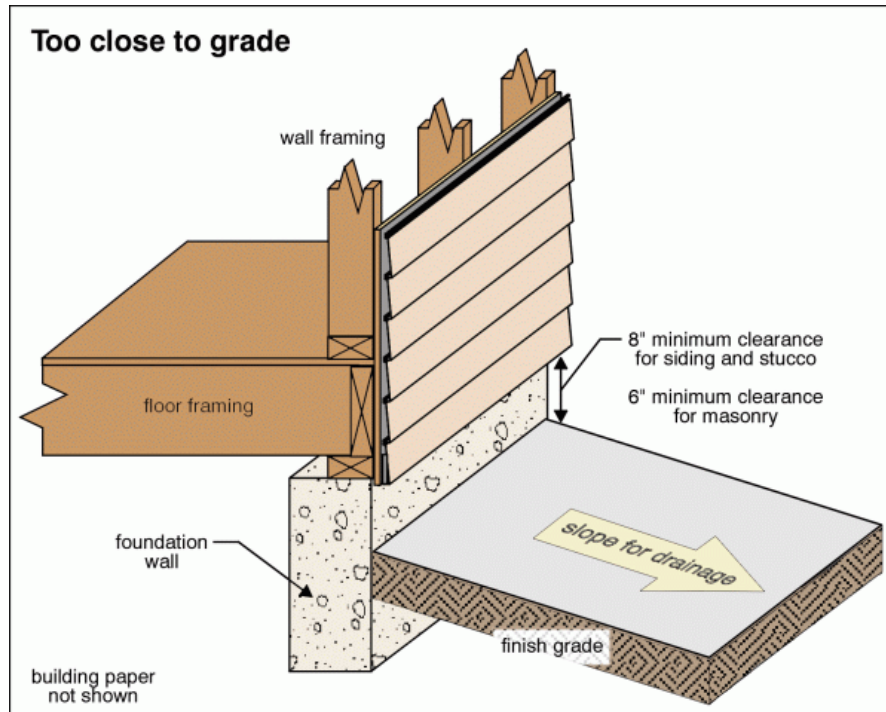
3. Condition: • [Too close to grade](#)

Task: Further evaluation

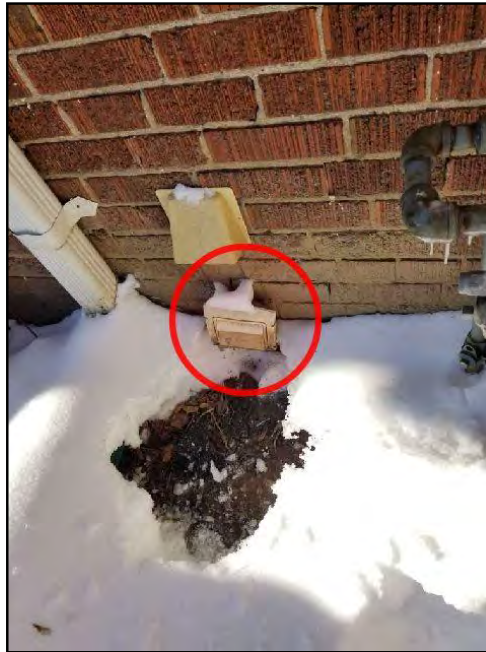
4. Condition: • Cover damaged
(Loose on wall. Resecure)

Location: Front

2. Cover damaged

Task: Repair

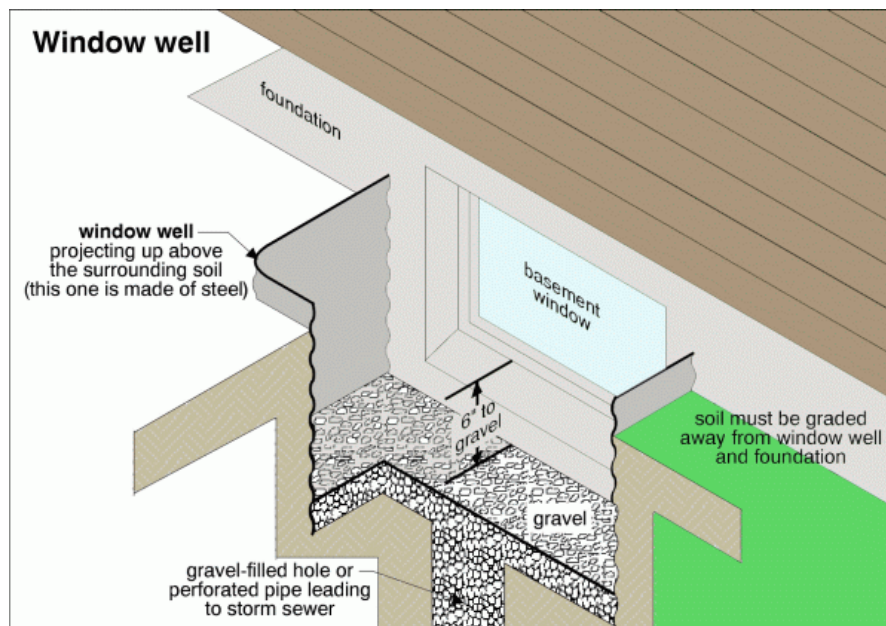
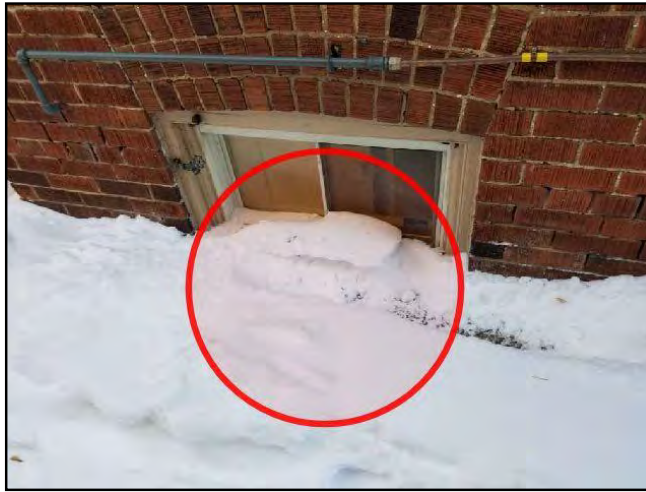
5. Condition: • [Missing](#)

Location: Right Side

3. Missing

Task: Install / Add New (as needed)

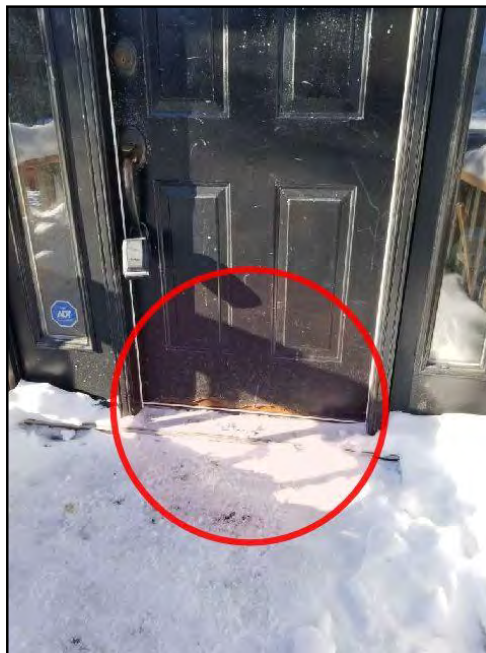
6. Condition: • [Rust](#)

Location: Front

4. Rust

Task: Repair

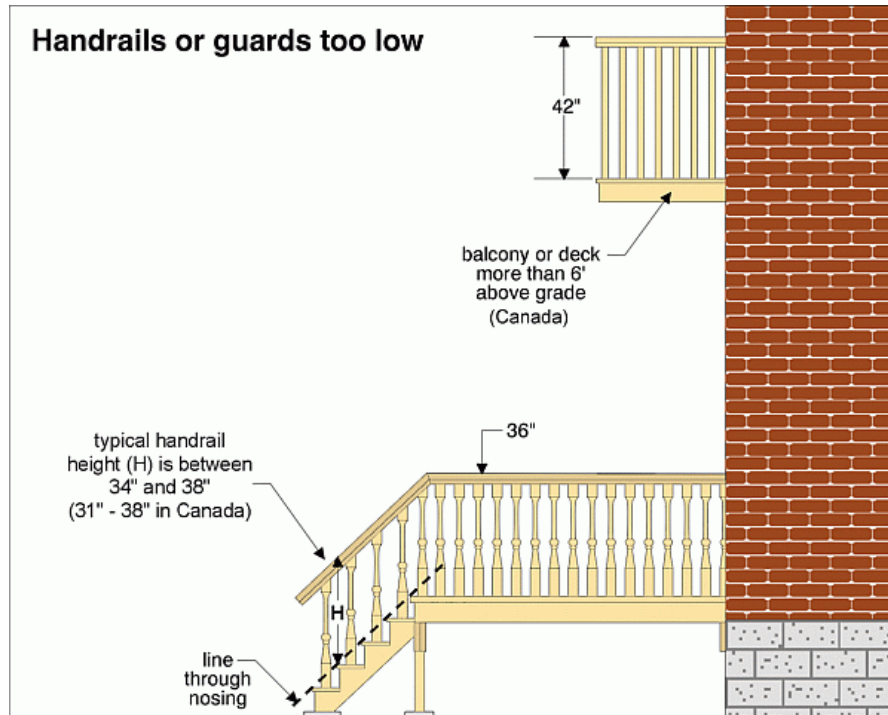
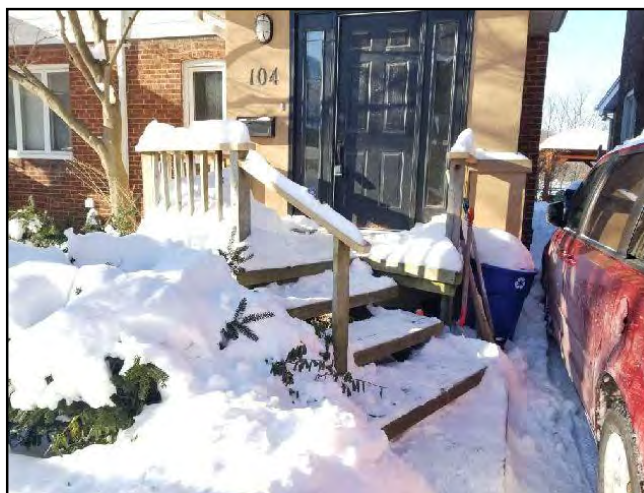
7. Condition: • [Too low](#)

Spacing between spindles is also too far apart.

Location: Front Porch & Rear Deck

Task: Adjust / Correct

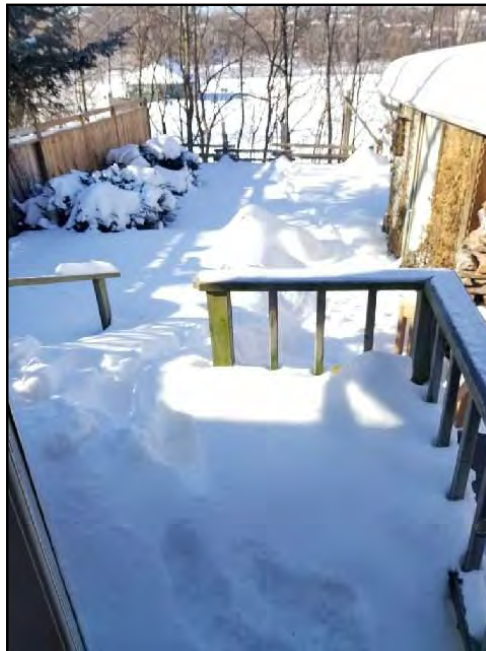
Prevents visibility.

6. Snow covered exterior: deck, patio, porch,...

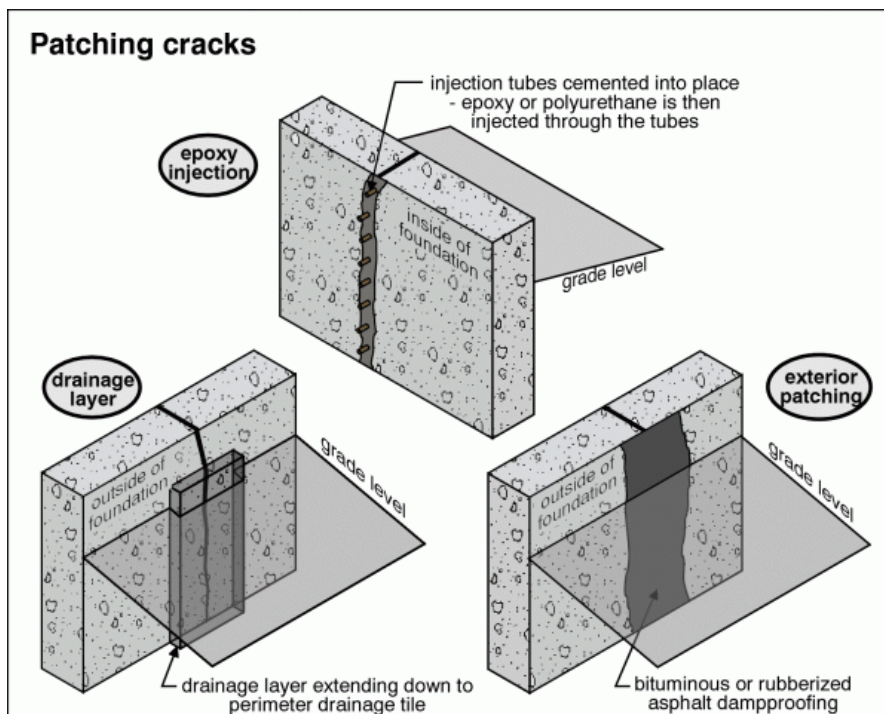
9. Condition: • Typical minor cracks

10. Condition: • [Typical minor settlement](#)

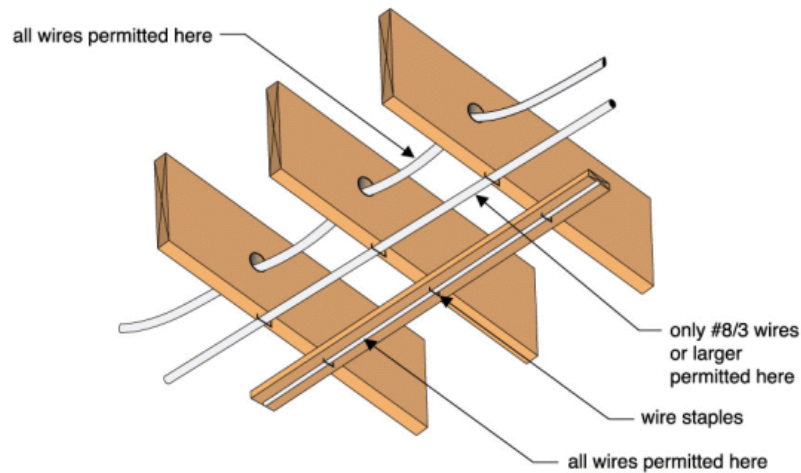
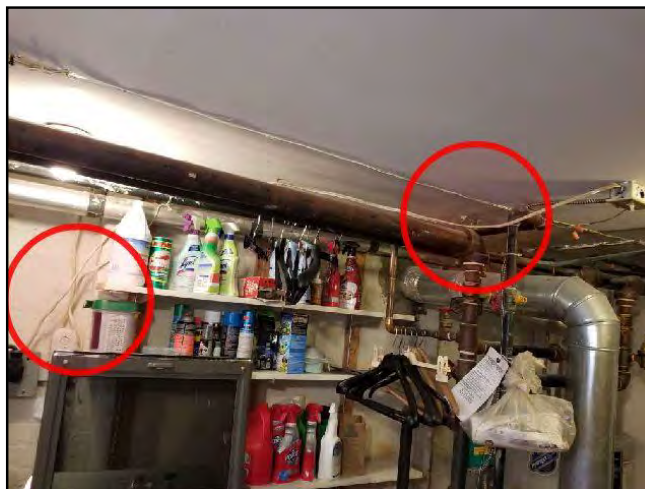
11. Condition: • [Exposed on walls or ceilings](#)

Location: Basement Laundry Area

Wire installations below floors

8. Exposed on walls or ceilings

Task: Repair

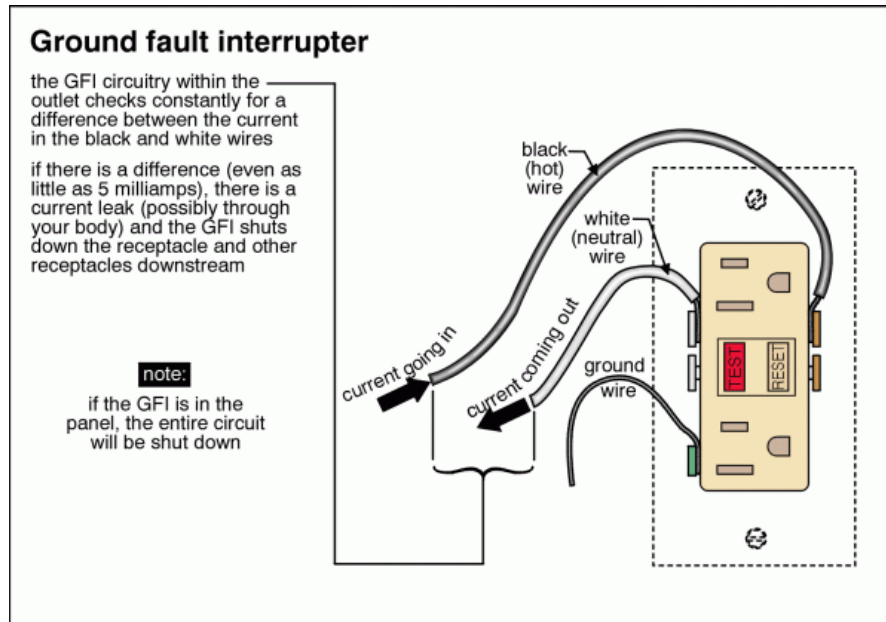
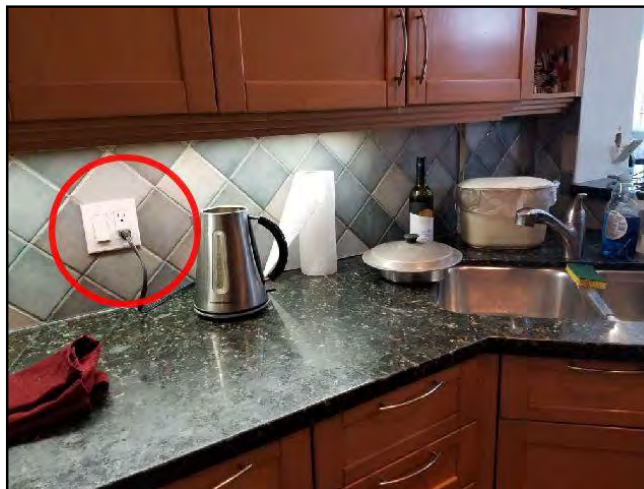
12. Condition: • [GFCI/GFI needed \(Ground Fault Circuit Interrupter\)](#)

Location: Kitchen

9. GFCI/GFI needed (Ground Fault Circuit...

Task: Install / Add New (as needed)

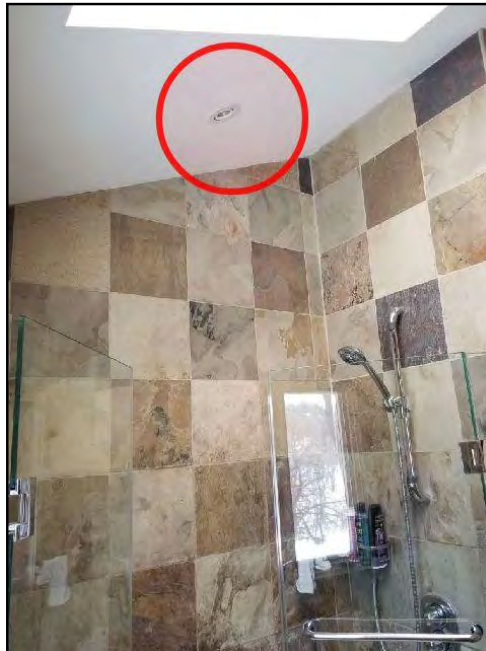
14. Condition: • [Conventional lights in wet areas](#)

Location: Second Floor Bathroom

10. Conventional lights in wet areas

Task: Replace

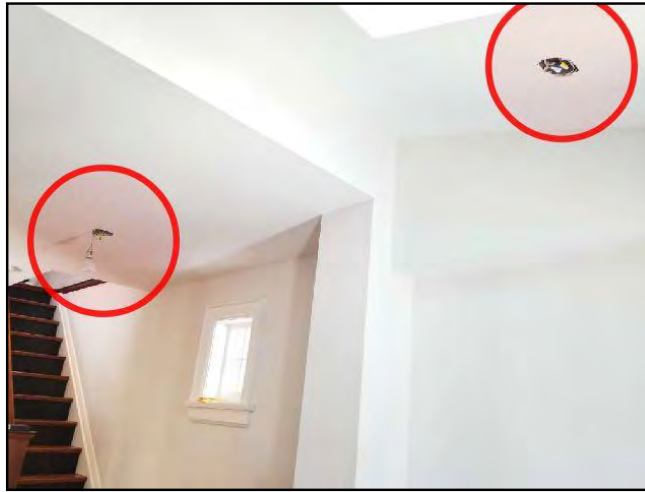
15. Condition: • [Missing](#)

Location: First Floor

11. Missing

Task: Install / Add New (as needed)

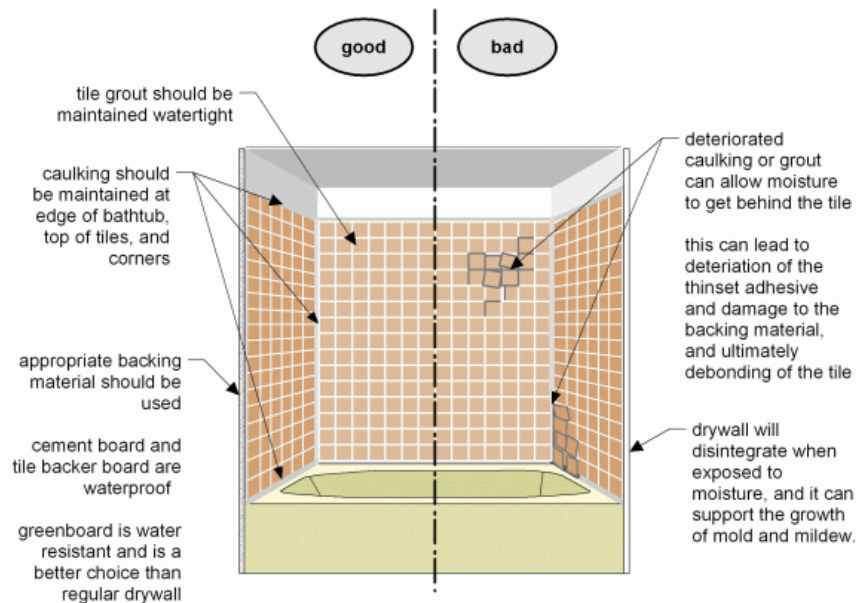
Expansion, debonding of tile due to moisture

24. Condition: • [Not smooth, impervious or water resistant](#)

Location: Second Floor Bathroom

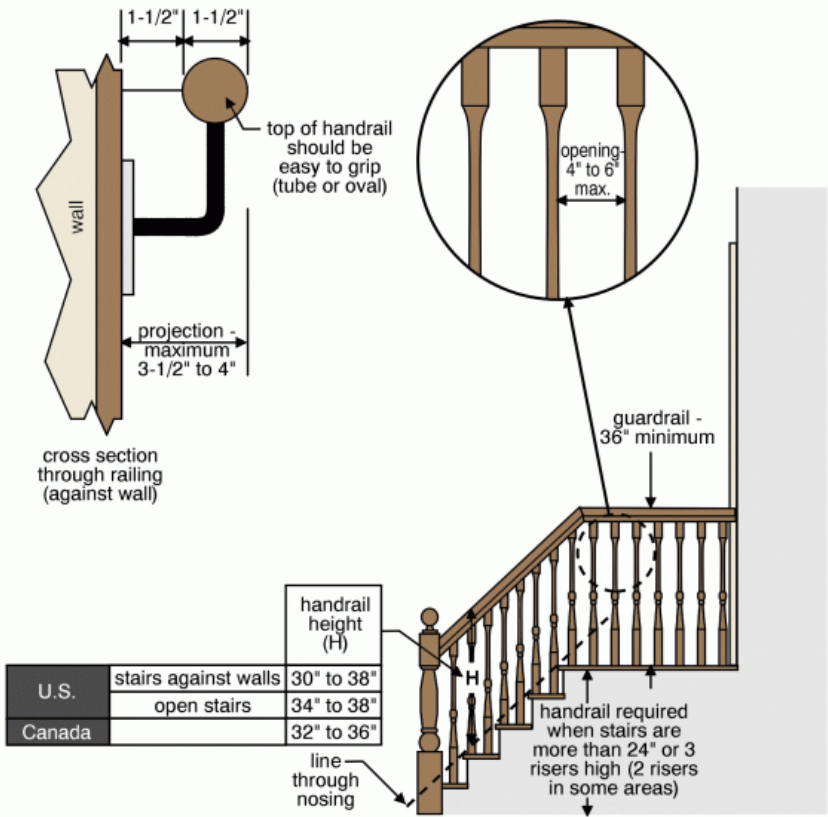
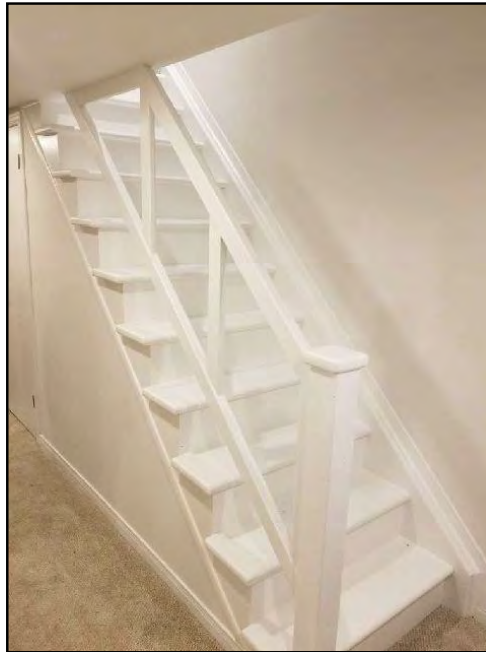
27. **Condition:** • [Too low](#)

Location: Throughout Staircase

20. Too low
