YOUR INSPECTION REPORT

210 Silver Birch Ave
Toronto, ON

PREPARED BY:
Jim Gibson, P.Eng.

RE: Report No. 38388
210 Silver Birch Ave
Toronto, ON

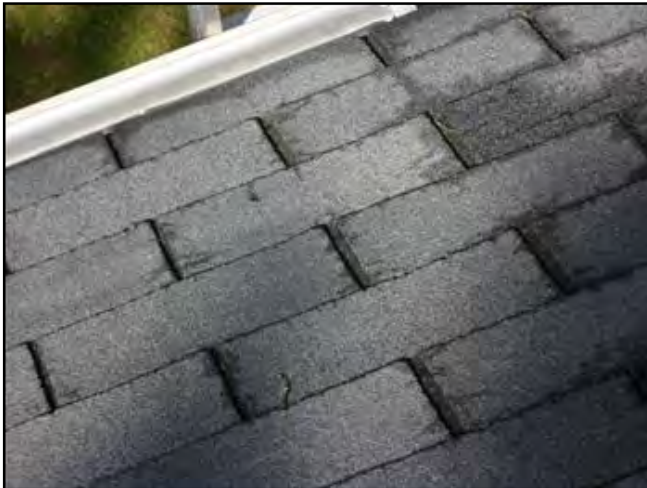
Location: West Second Floor

Condition: • Damage

Damage

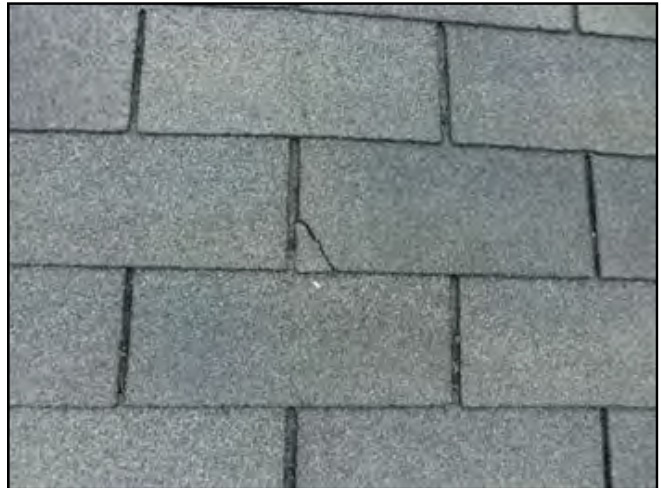
Damage

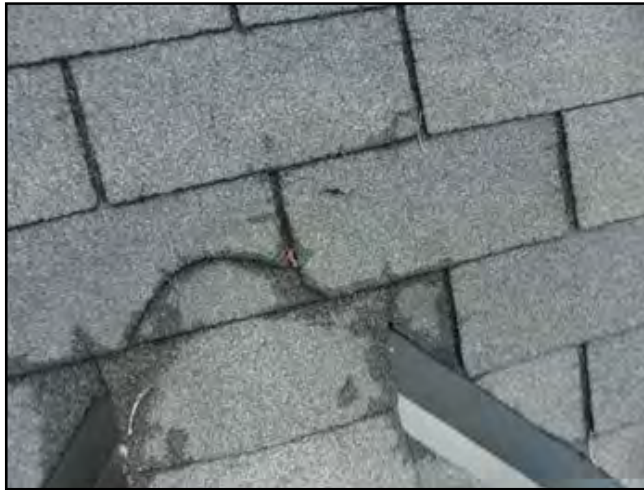
Damage

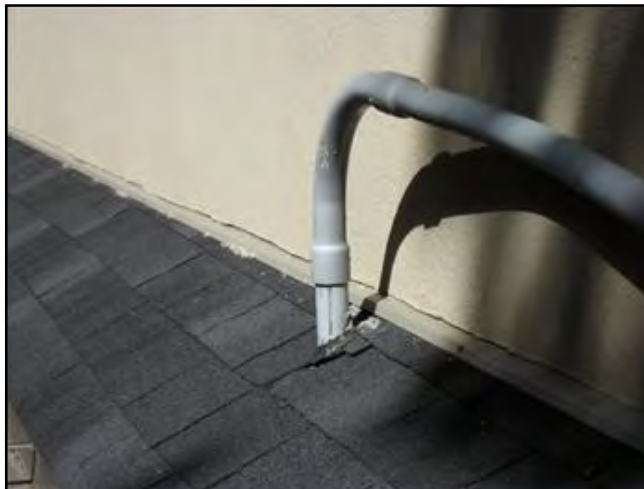
Location: South First Floor

Condition: • [Missing](#)

Caulking - deteriorated or missing

Missing

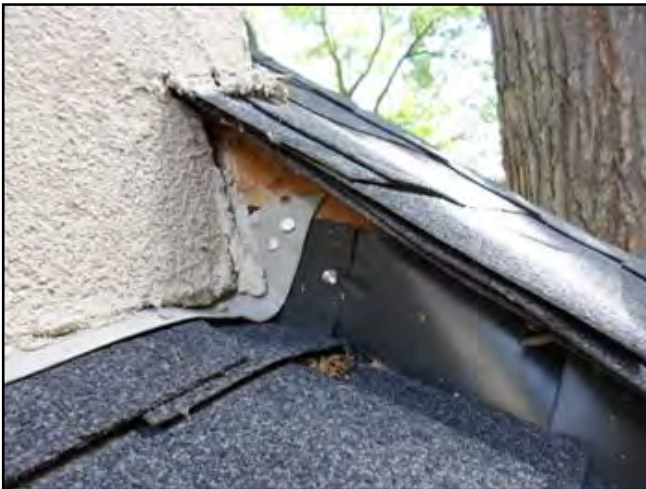
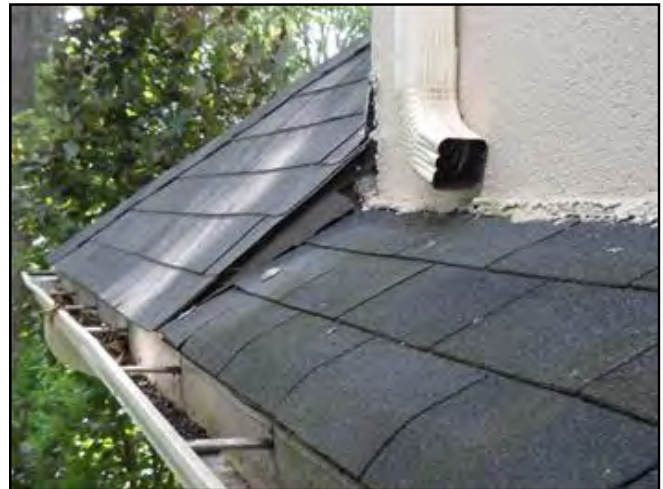
Condition: • [Counter flashing - missing or ineffective](#)

Caulking - missing

Counter flashing - missing or ineffective

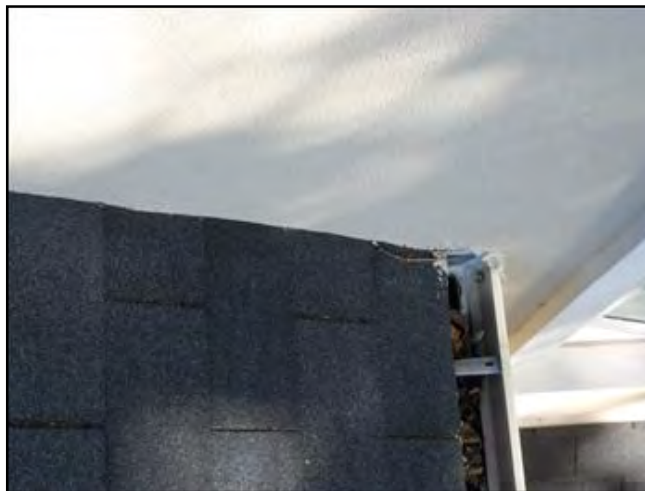
Condition: • [Kick-out flashing missing or ineffective](#)

Kick-out flashing missing or ineffective

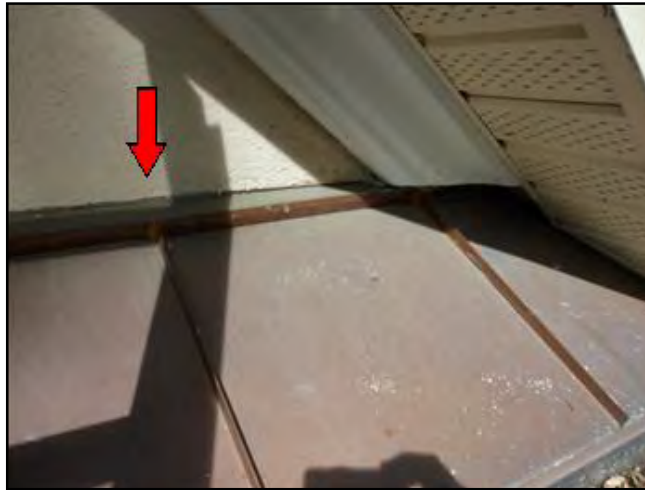
Condition: • [Caulking deteriorated/missing](#)

Caulking deteriorated/missing

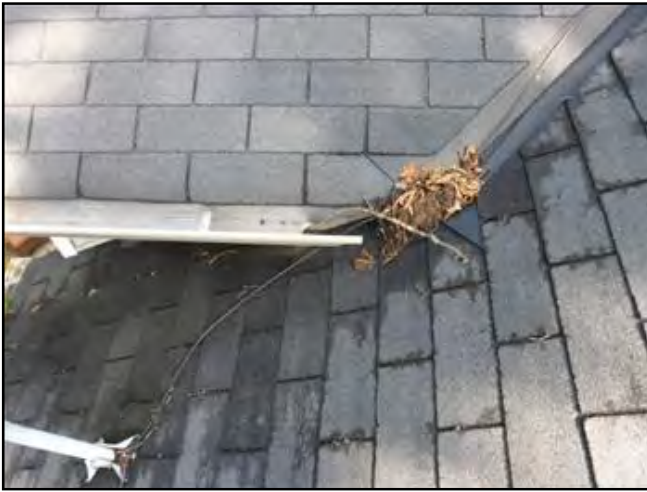
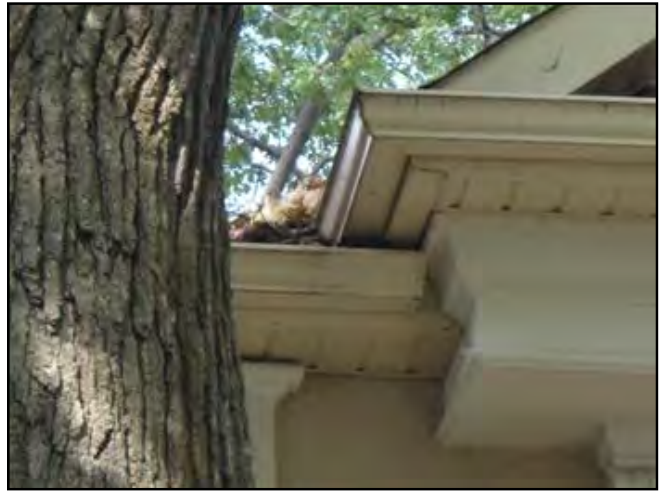
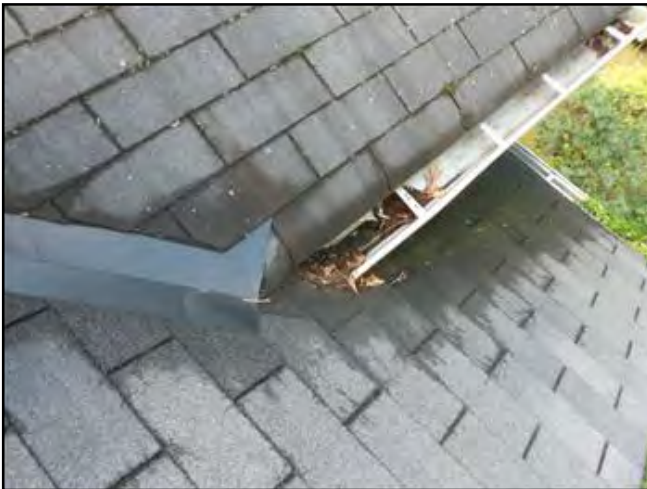
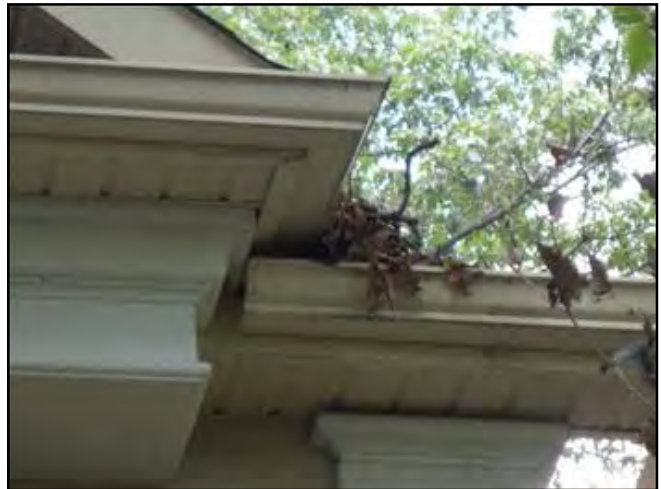
Location: Northeast, Southeast, Northwest and Southwest Second Floor

Condition: • [Discharge onto lower roof - causes premature roof wear](#)

Discharge onto lower roof - causes...

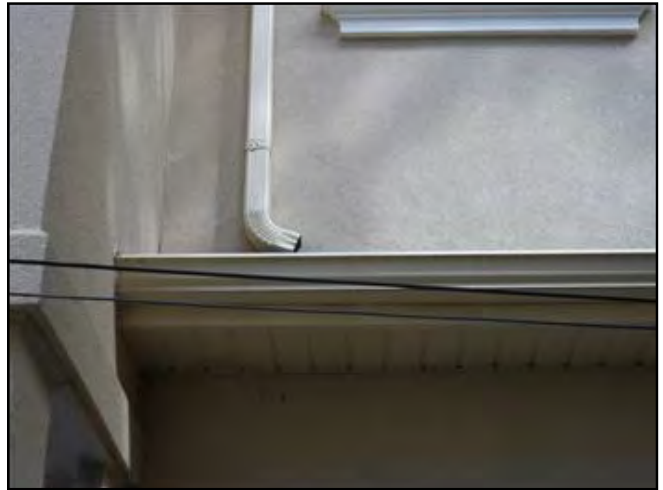
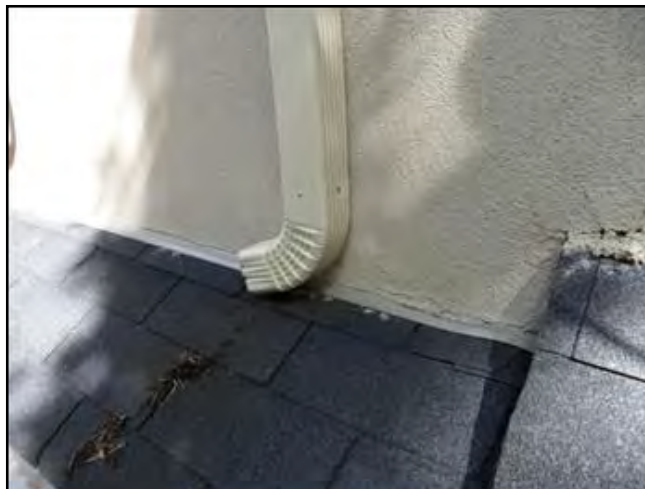
Condition: • [Discharge onto roof - extend to lower gutter to protect lower roof](#)

Discharge onto roof - extend to lower...

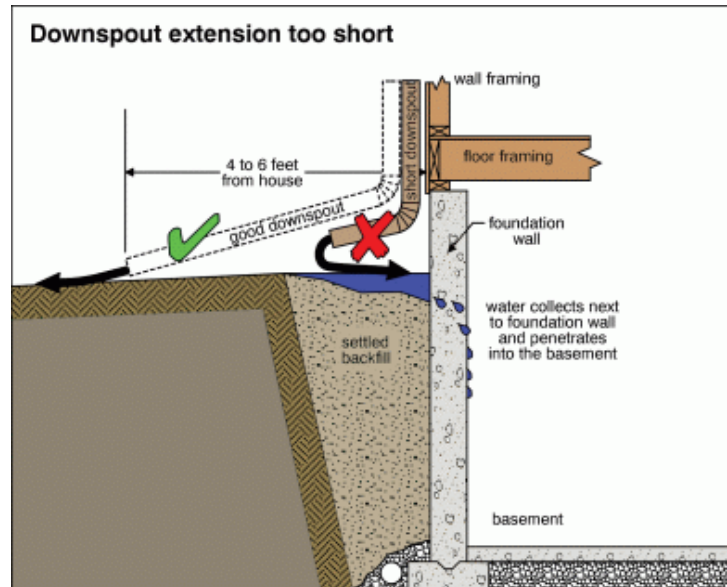
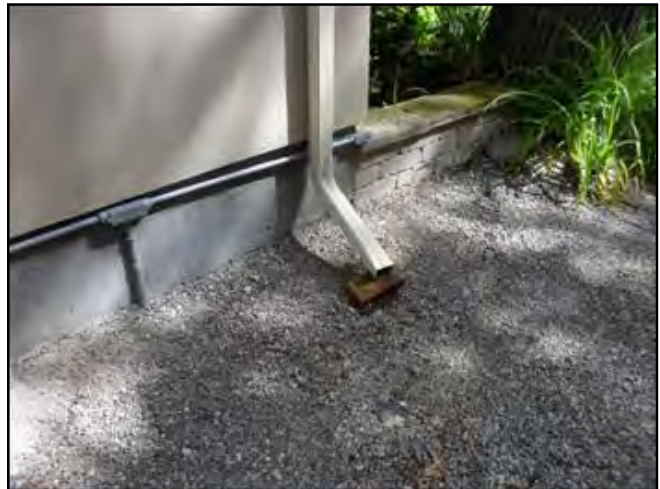
Condition: • [Discharge too close to home. It should typically direct water at least 6 feet from the building.](#)

Discharge too close to home. It should...

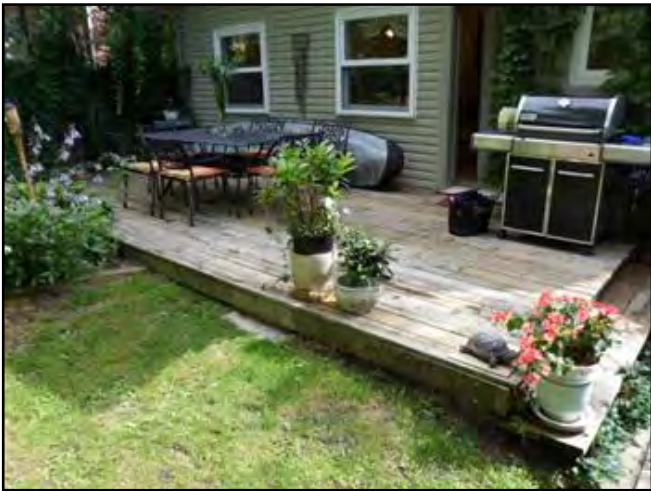
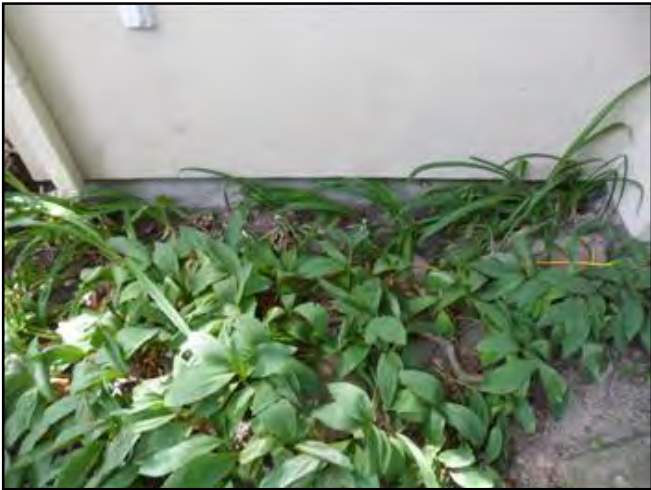
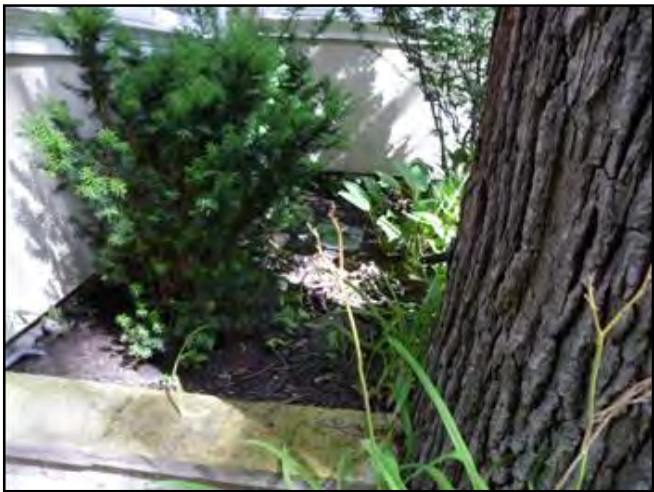
Condition: • [Grading directs water toward house](#)

Grading directs water toward house

Task: Repair

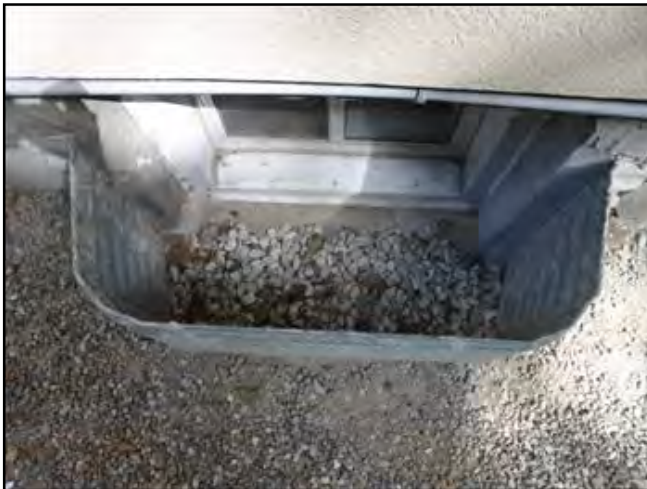
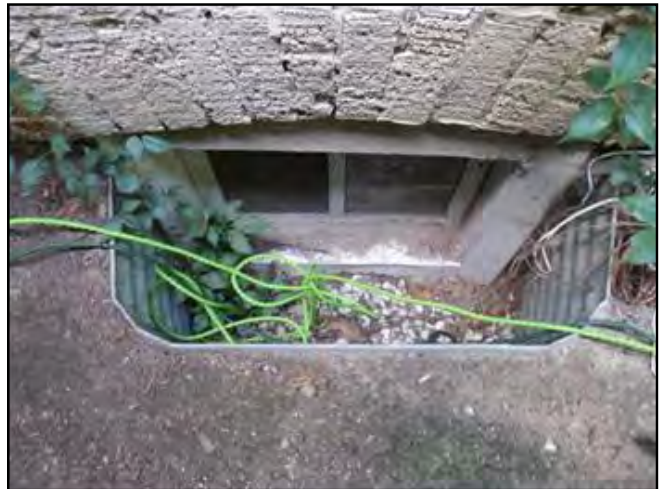
Location: Northwest, Southeast

Condition: • Window well - missing 6 to 8 inches clearance below window

Window well - missing 6 to 8 inches...

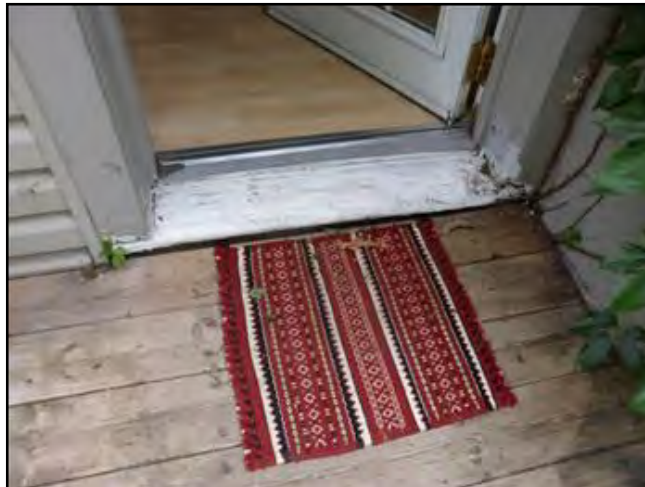
Condition: • Water damage

Task: Repair

Time: Less than 1 year

Cost: \$250 - \$500

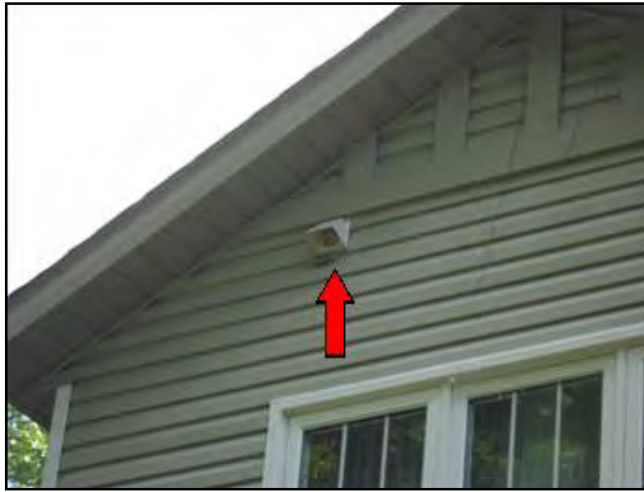
Condition: • Vent Cap (for Second Floor Bathroom Exhaust Fan) - suspect, loose

Vent Cap - suspect, loose

Task: Repair

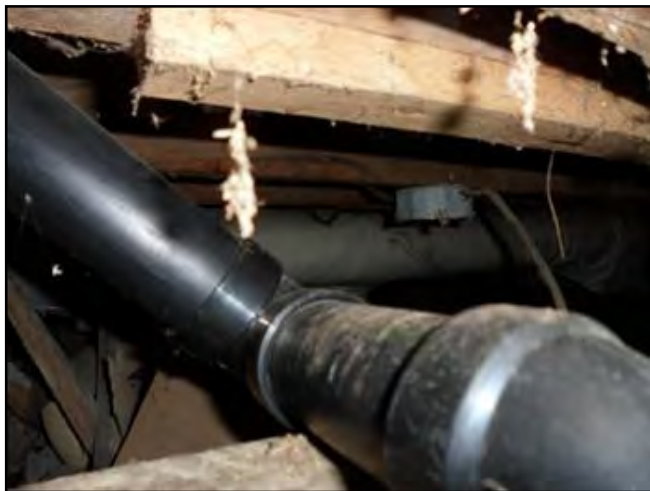
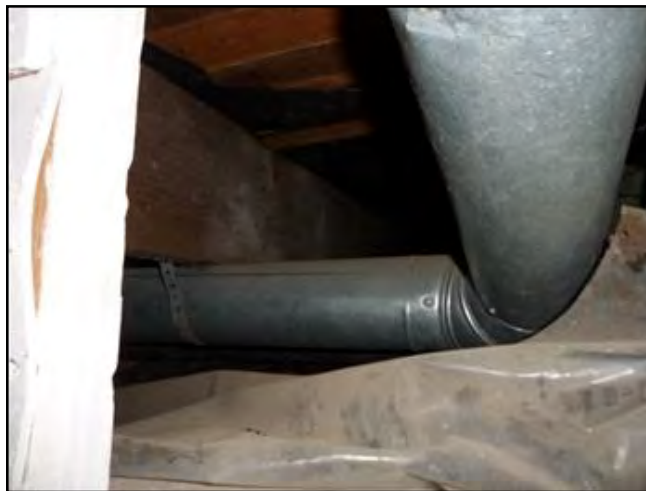
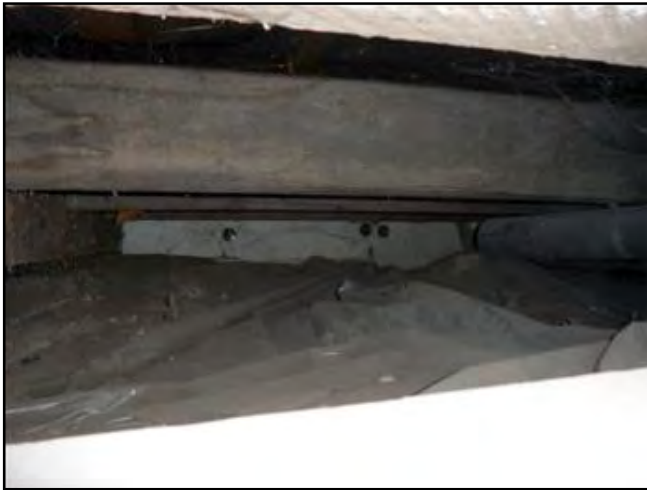
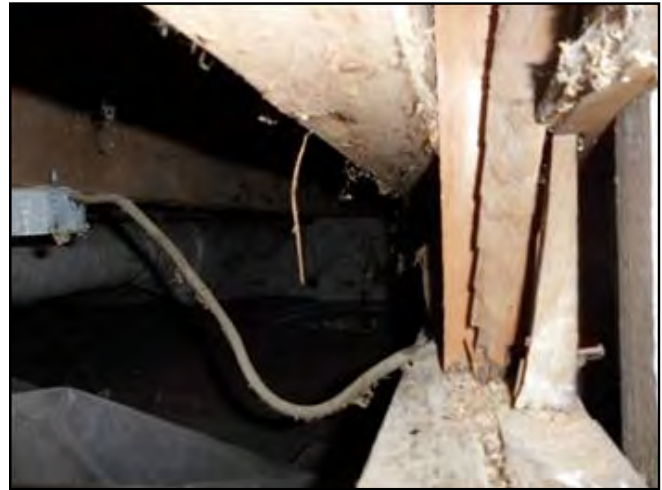
Condition: • Restricted access (due to inadequate clearance)

Restricted access (inadequate clearance)

Time: Less than 1 year

Cost: Depends on work needed

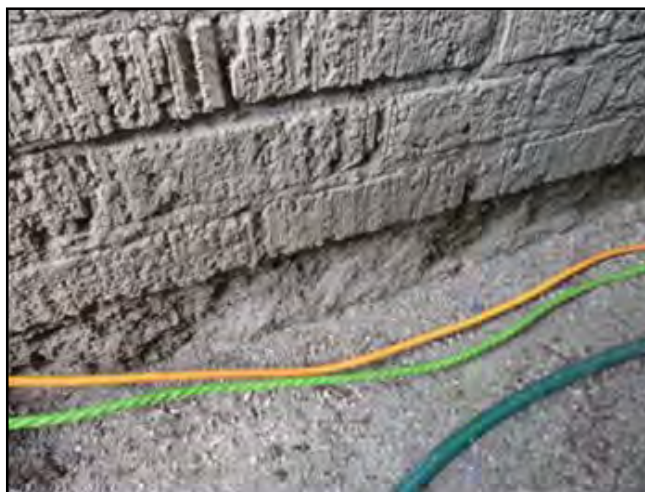
Condition: • Freeze / thaw damage (spalling)

Ex: Freeze / thaw damage (spalling)

Recommend parging surface (cosmetic issue at present)

Task: Repair

Time: Less than 5 years

Cost: Depends on work needed

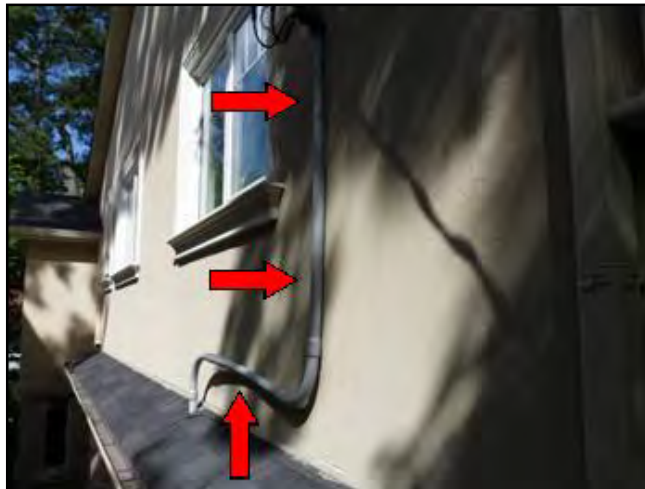
Location: Southeast Second Floor

Condition: • Mast clamps - missing/damaged/loose

Mast clamps - missing/damaged/loose

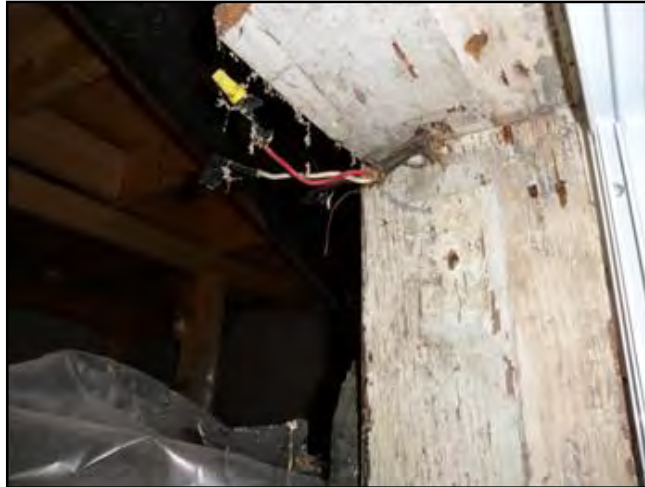
Location: East Crawlspace

Condition: • [Exposed](#)

Junction Box - missing

Exposed

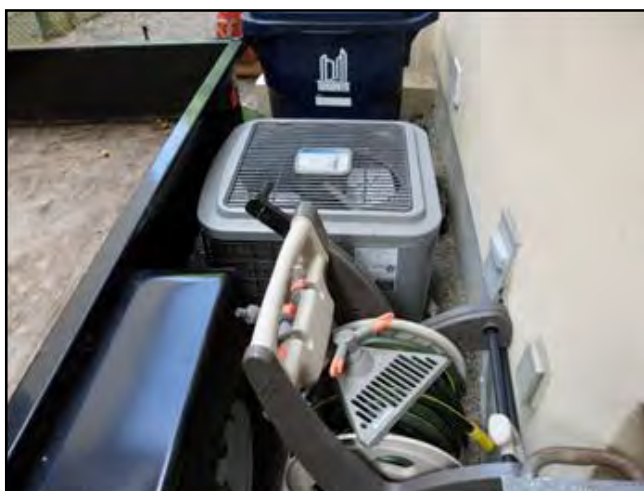
Condition: • Near end of normal lifespan

Near end of normal lifespan

Task: Replace

Time: Unpredictable

Cost: \$2,500 - and up

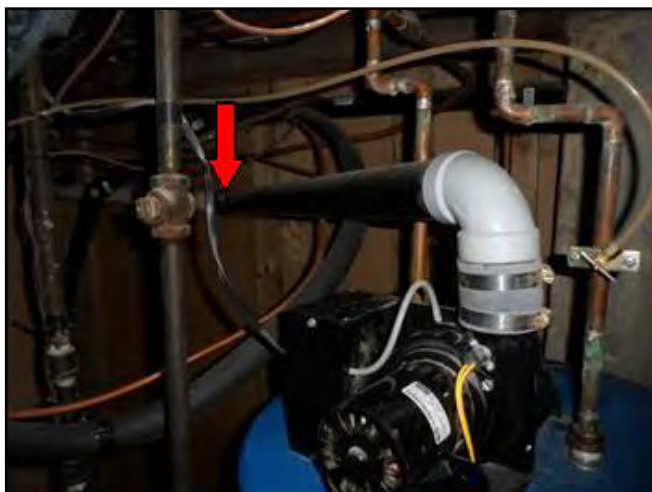
Condition: • Exhaust Piping - slope suspect, termination incorrect at exterior (risk of obstruction)

Exhaust Piping - slope suspect

Task: Repair

Time: Immediate

Cost: Minor

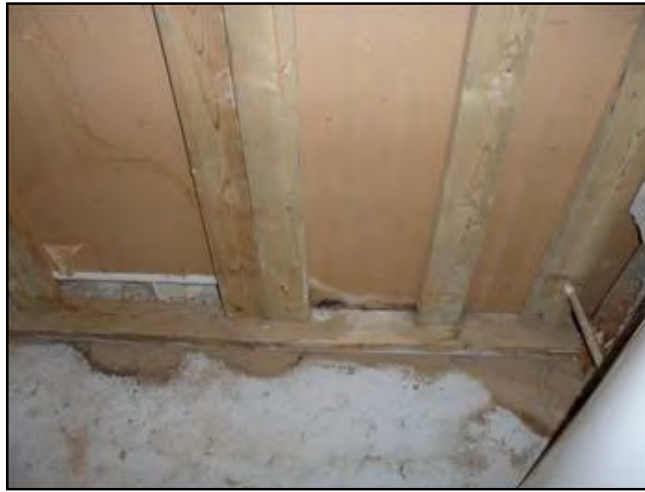
Condition: • [Leak](#)

Caulking - deteriorated or missing

Mold noted

Leak

Task: Repair

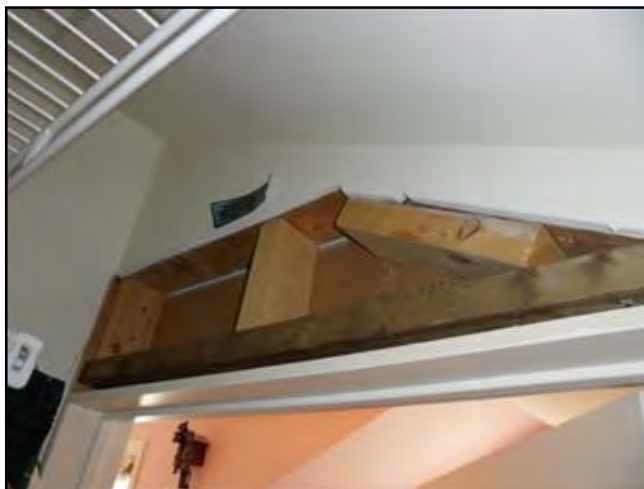
Condition: • Drywall - installation incomplete

Drywall - installation incomplete

Task: Repair

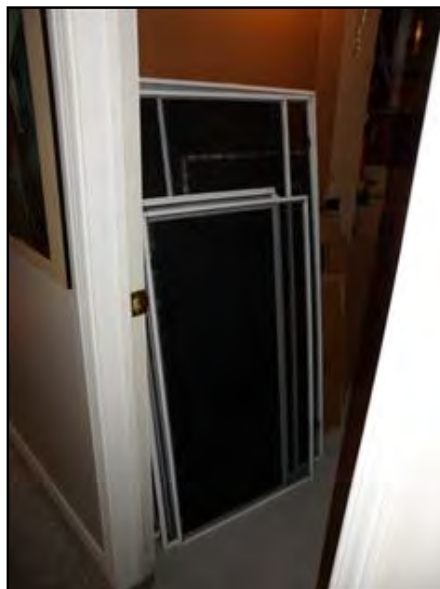
Condition: • Screens - not installed

Screens - not installed

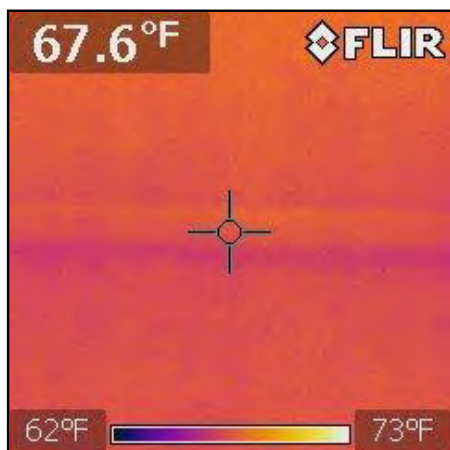
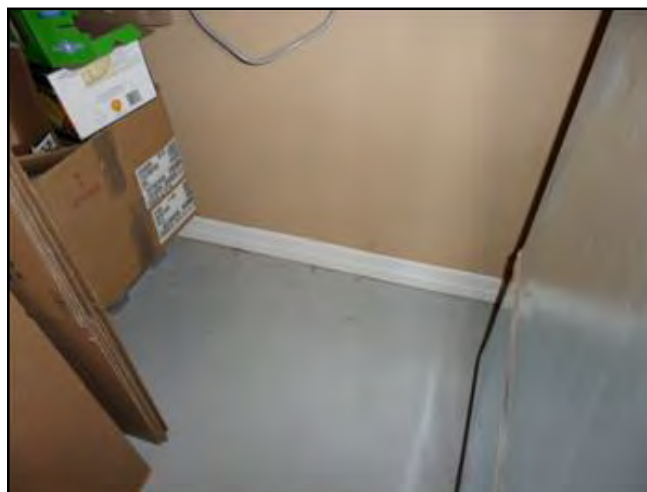
Location: South Basement

Condition: • Moisture detected with moisture meter

Moisture detected with moisture meter

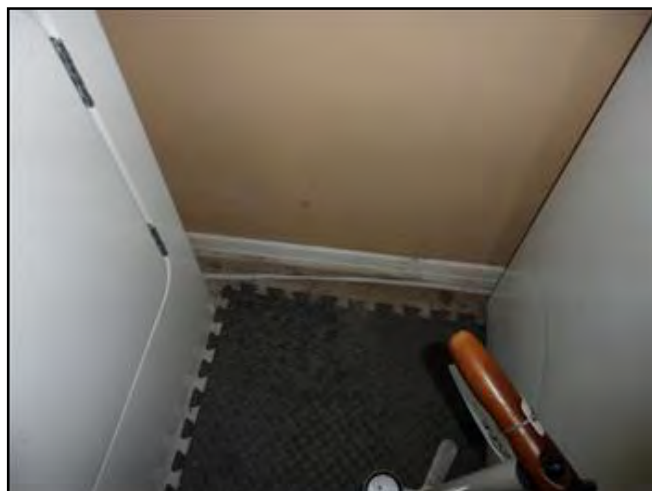
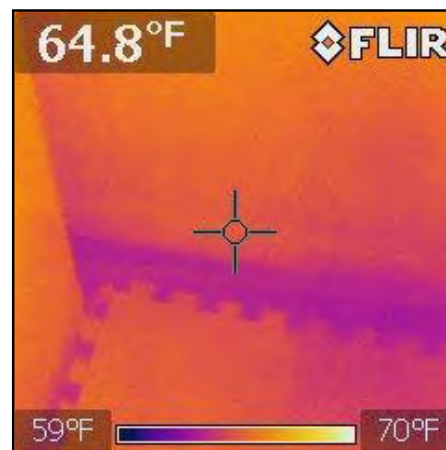
Location: Northwest Basement

Condition: • Moisture detected with moisture meter

Moisture detected with moisture meter

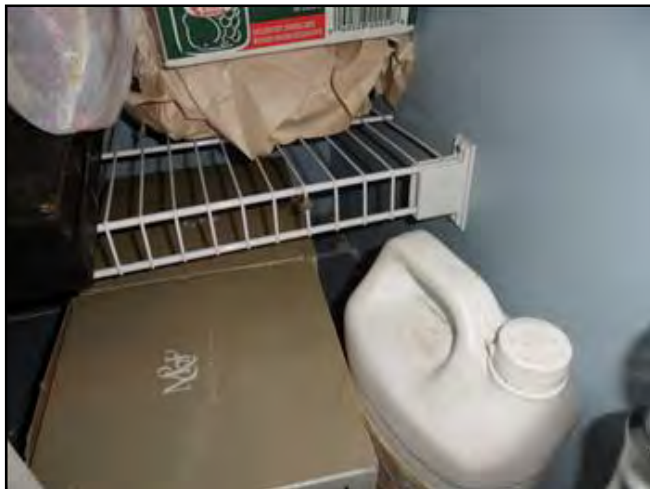
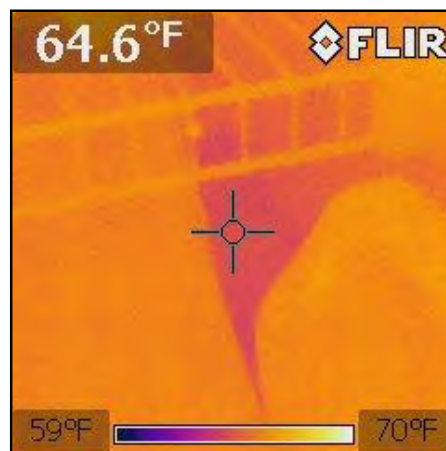
Location: Southwest Basement

Condition: • Moisture detected with moisture meter

Moisture detected with moisture meter

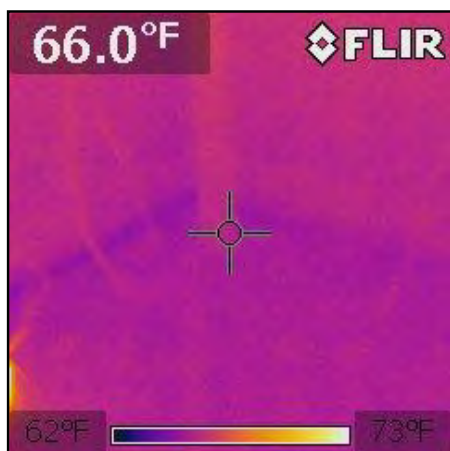
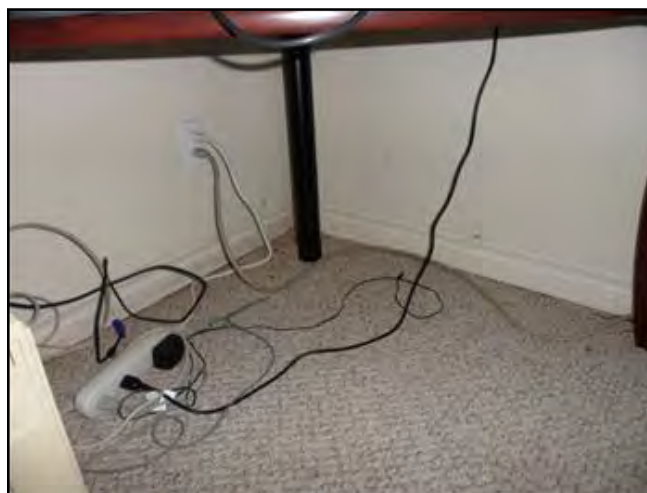
Location: Southeast Basement

Condition: • Moisture detected with moisture meter

Moisture detected with moisture meter

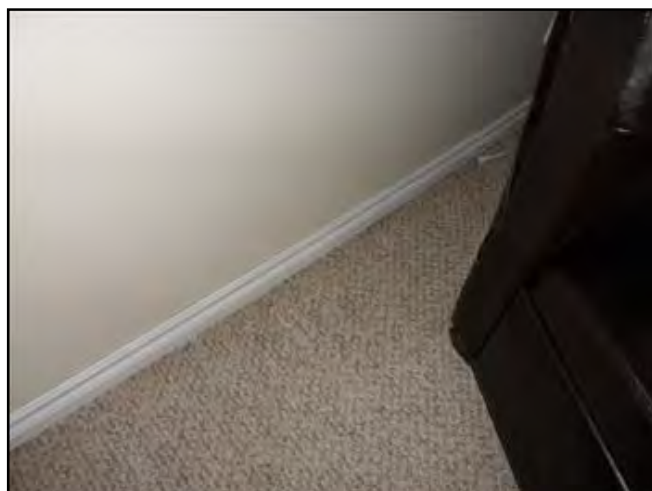
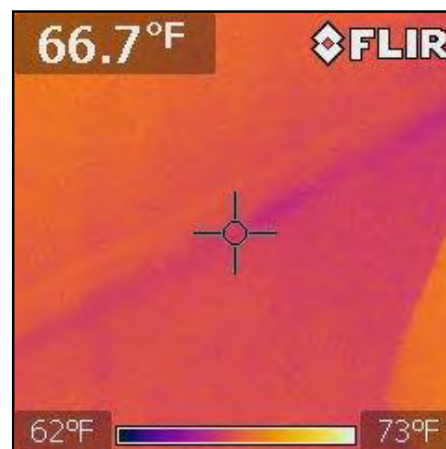
Condition: • Moisture detected with moisture meter

Moisture detected with moisture meter

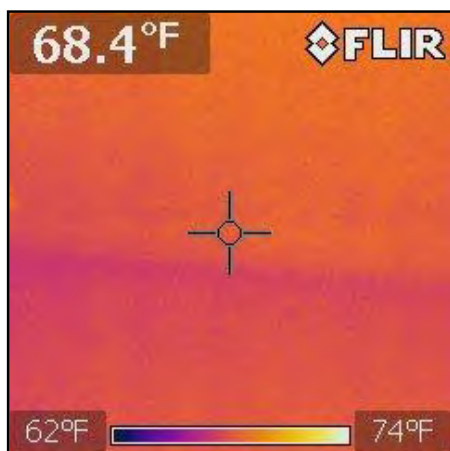
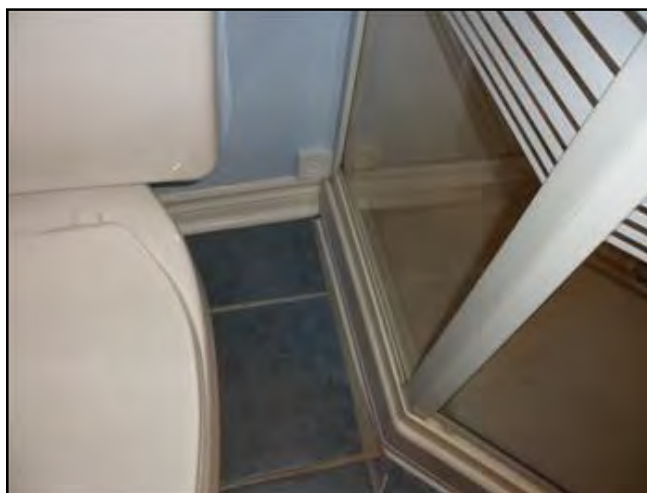
Moisture detected with moisture meter
