YOUR INSPECTION REPORT

210 Silver Birch Ave
Toronto, ON

PREPARED BY:
Jim Gibson, P.Eng.

RE: Report No. 38388
210 Silver Birch Ave
Toronto, ON

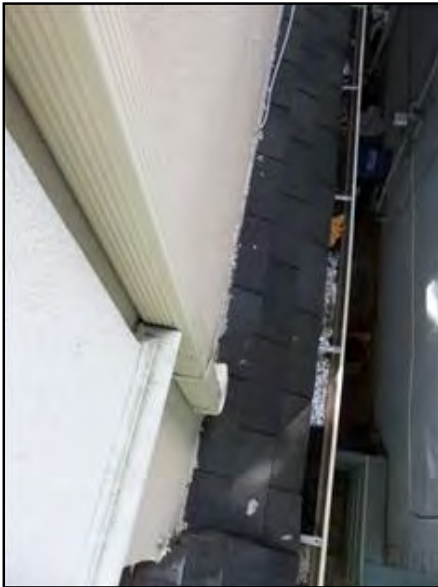
Discharge onto roof - extend to lower...

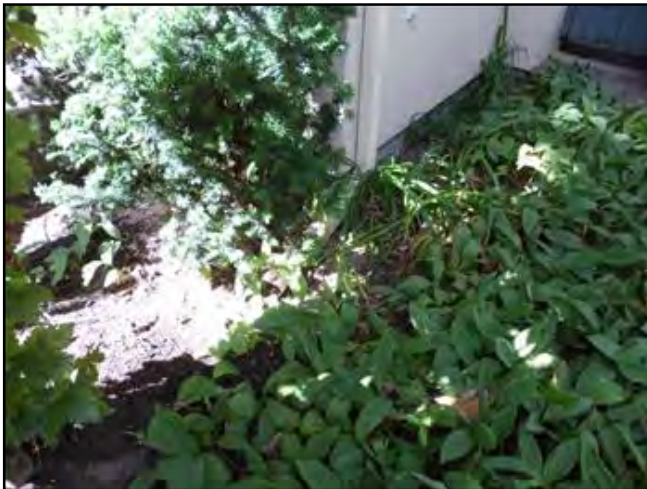
Discharge too close to home. It should...

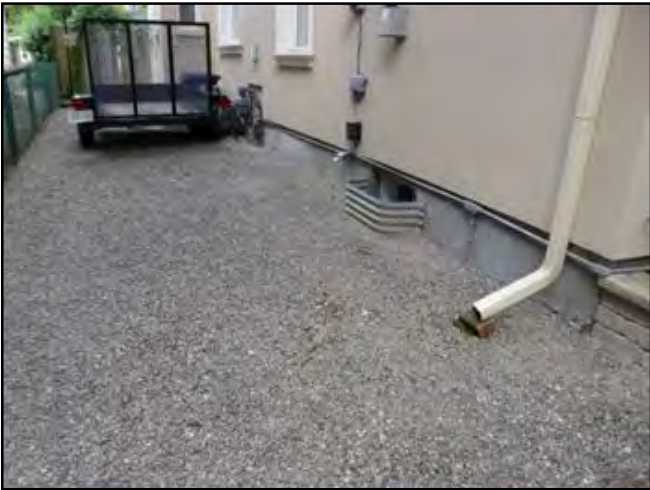
Grading directs water toward house

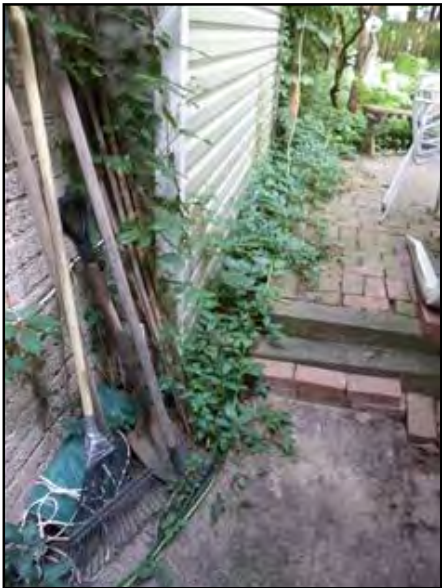
Grading directs water toward house

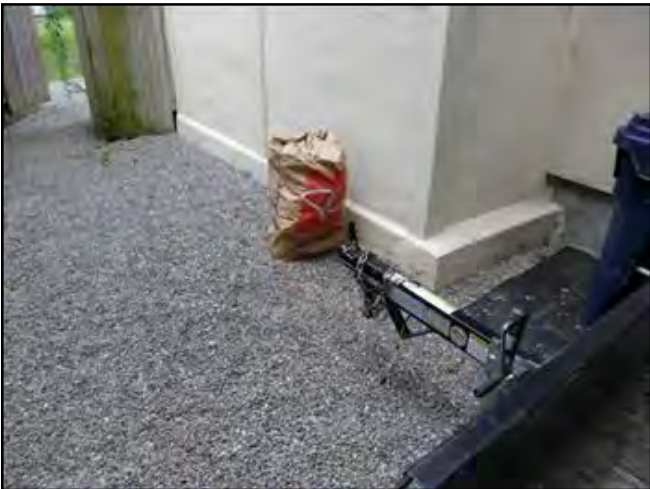
Grading directs water toward house

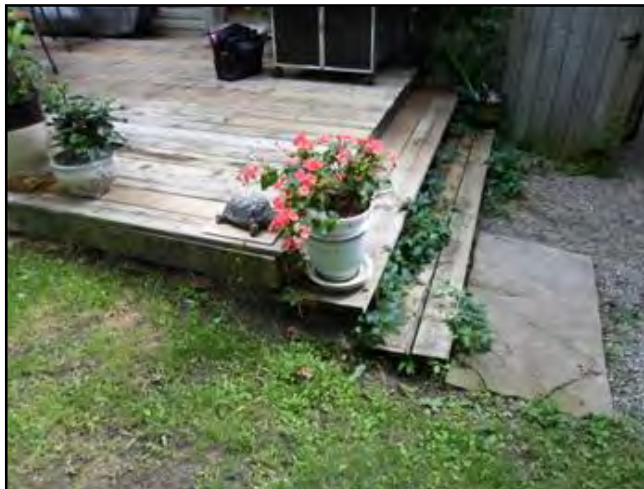
Ex : Wood-soil contact

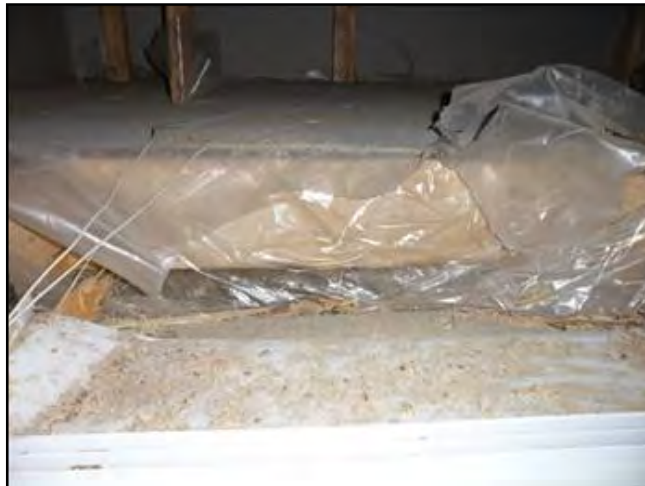
Concrete Formwork - not removed

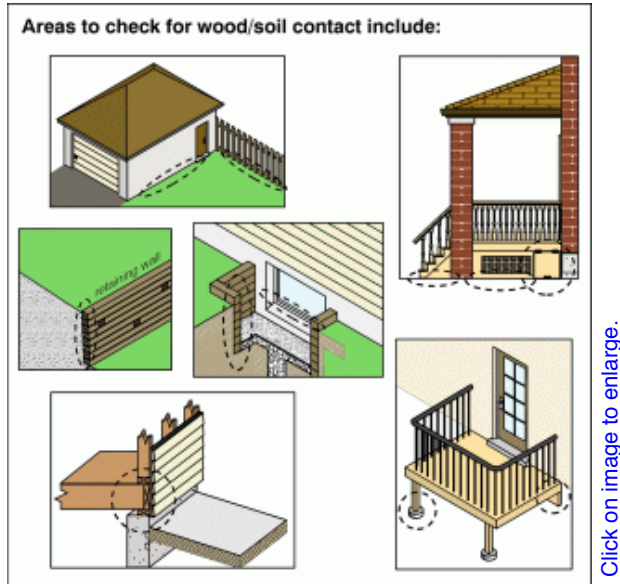
Condition: • [Wood/soil contact makes house vulnerable to termites](#)

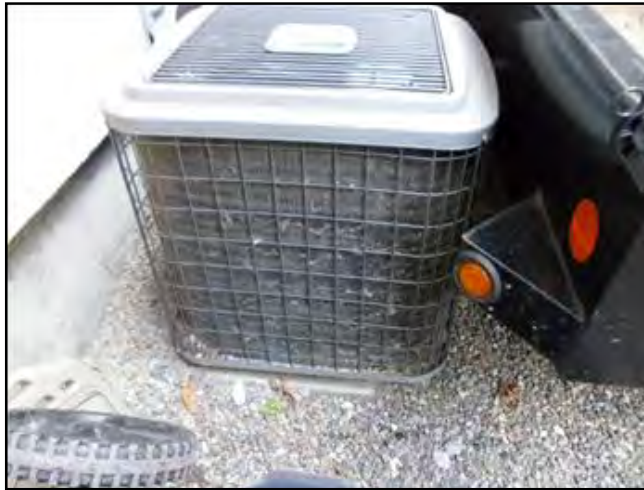
Coil dirty

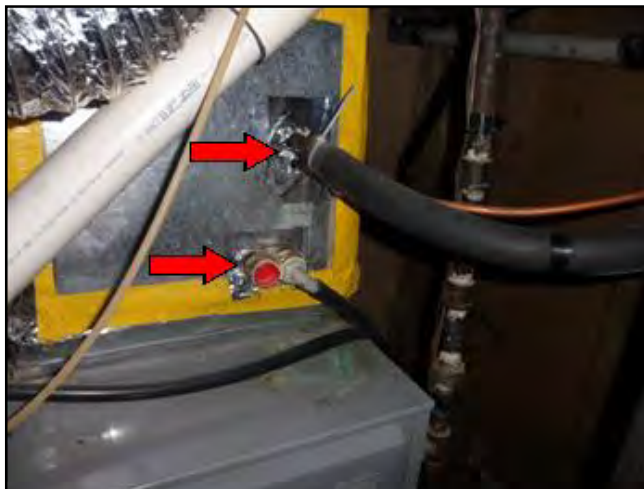
Unsealed gap at plenum

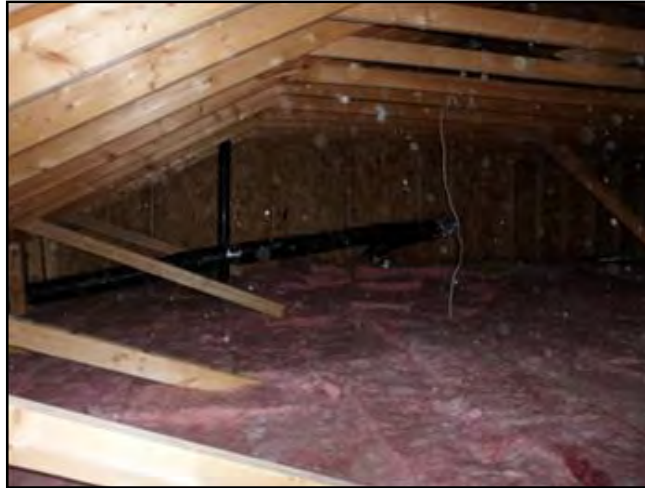
Ductwork arrangement poor

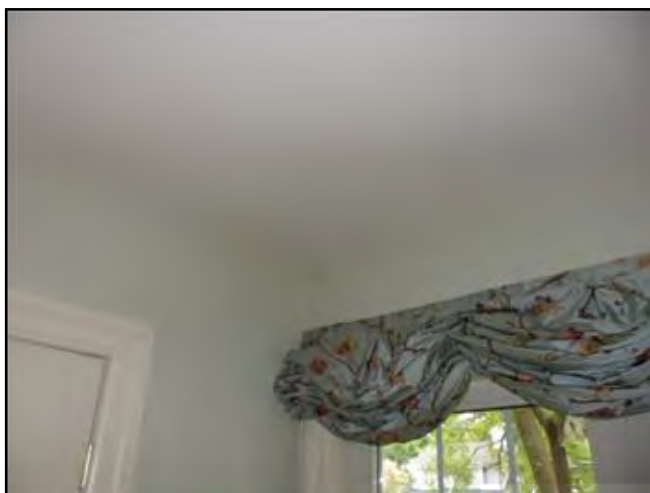
Location: East Bedroom

No elevated moisture found with meter
